Failure tree

IVECO

Edition: 2004-02
SW31_13e

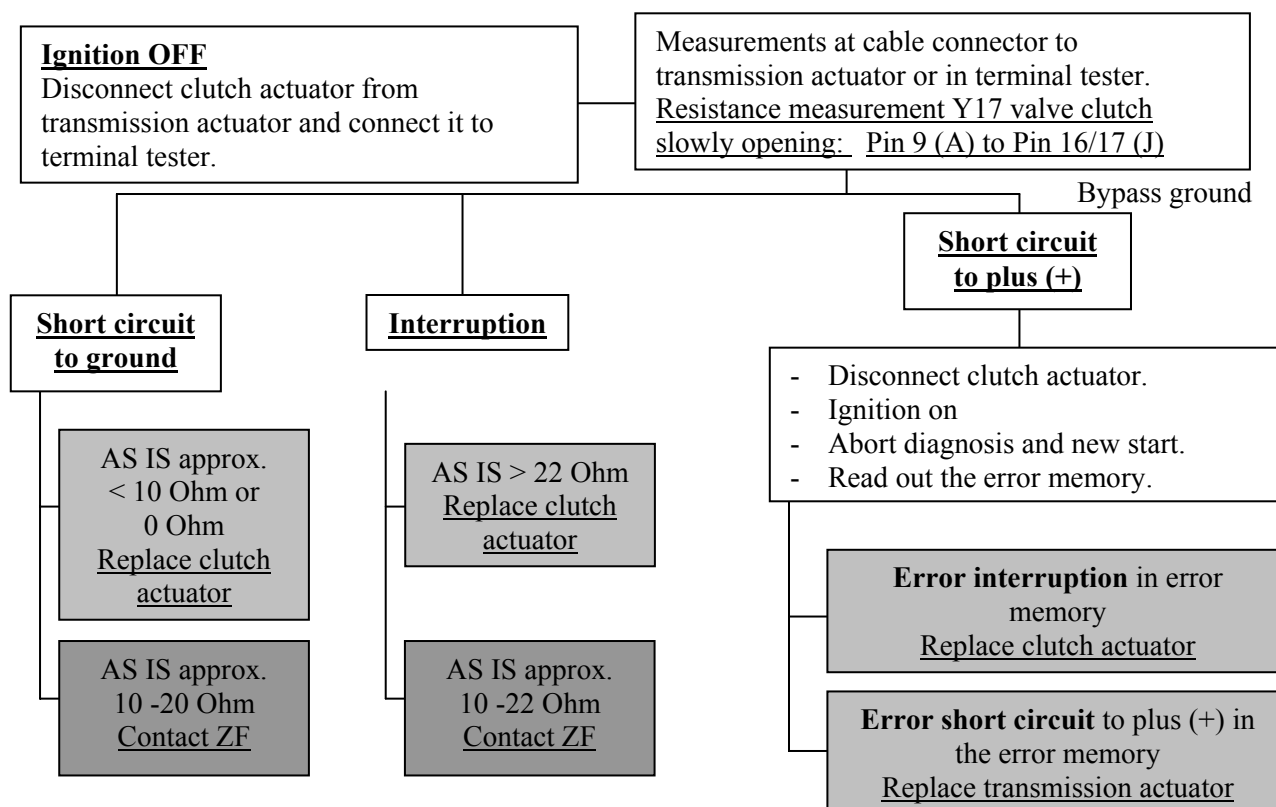
Iveco error number: 12, 32, 52

Error description: Error 18: Short circuit to ground Y17 valve clutch slowly opening.
Error 50: Interruption. Y17 valve clutch slowly opening.
Error 82: Short circuit to plus (+) Y17 valve clutch slowly opening.

Error rectification:

Note
Correct value = 15.6 Ohm. However, to take proper account of temperature-related factors and measurement errors and/or measurement conditions, ensure system stays within the above-mentioned tolerance limits!

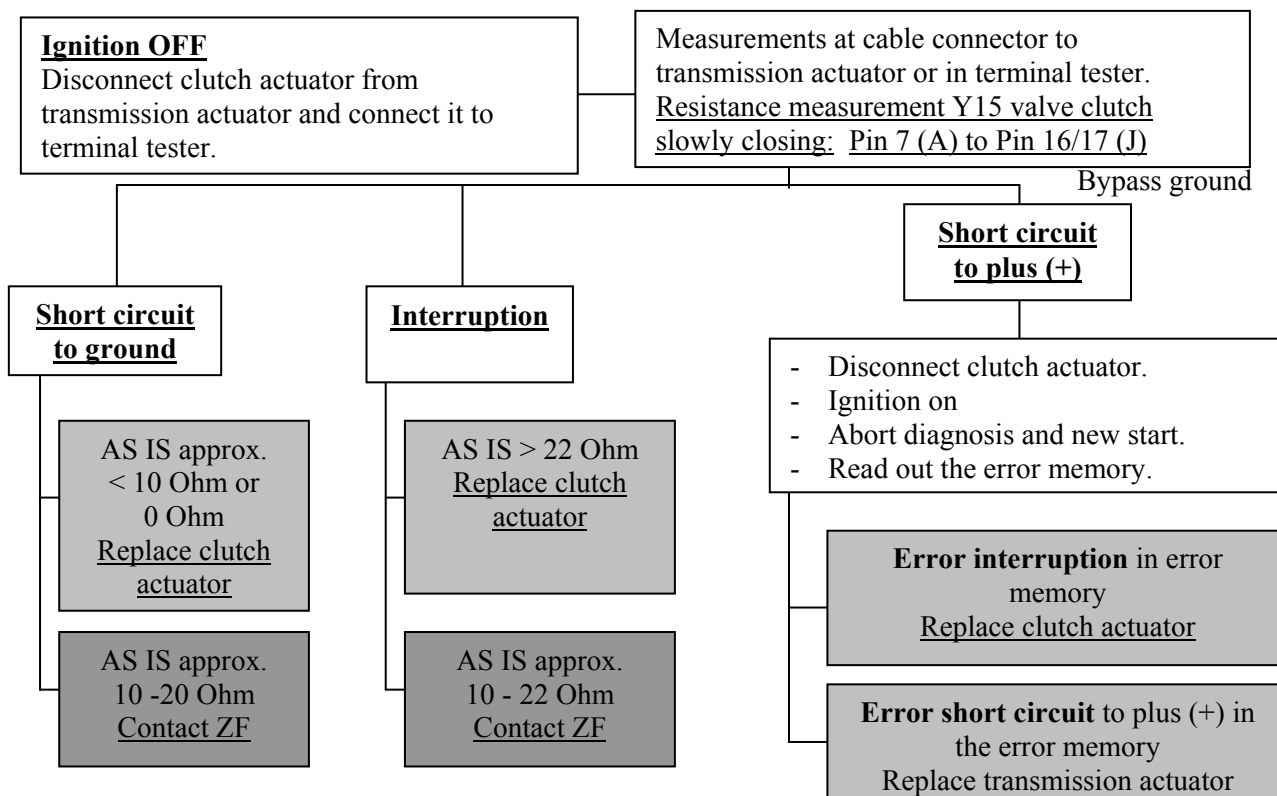
Iveco error number: 13, 33, 53

Error description: Error 19: Short circuit to ground Y15 valve clutch slowly closing.
Error 51: Interruption Y15 valve clutch slowly closing.
Error 83: Short circuit to plus (+) Y15 valve clutch slowly closing.

Error rectification:

Note
Correct value = 15.6 Ohm. However, to take proper account of temperature-related factors and measurement errors and/or measurement conditions, ensure system stays within the above-mentioned tolerance limits!

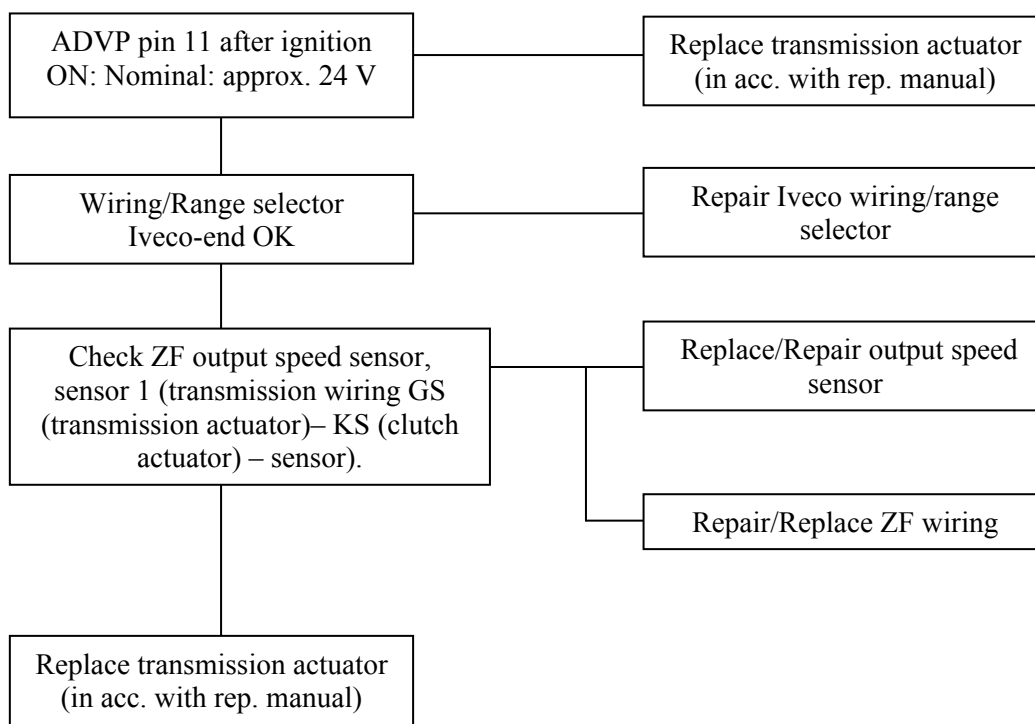
Iveco error number: 16, 36, 56

Error description: Error 22: Short circuit to ground at ADVP output.
Error 54: Interruption at ADVP output.
Error 86: Short circuit to plus (+) at ADVP output.

Error rectification:

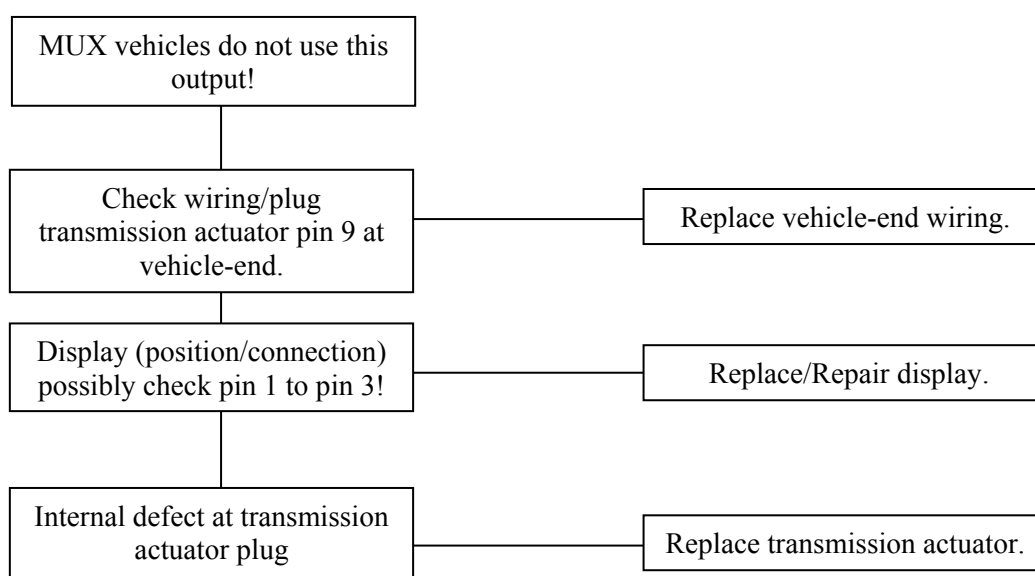
Iveco error number: 19

Error description: Short circuit to ground at SD output to display.

Error rectification:

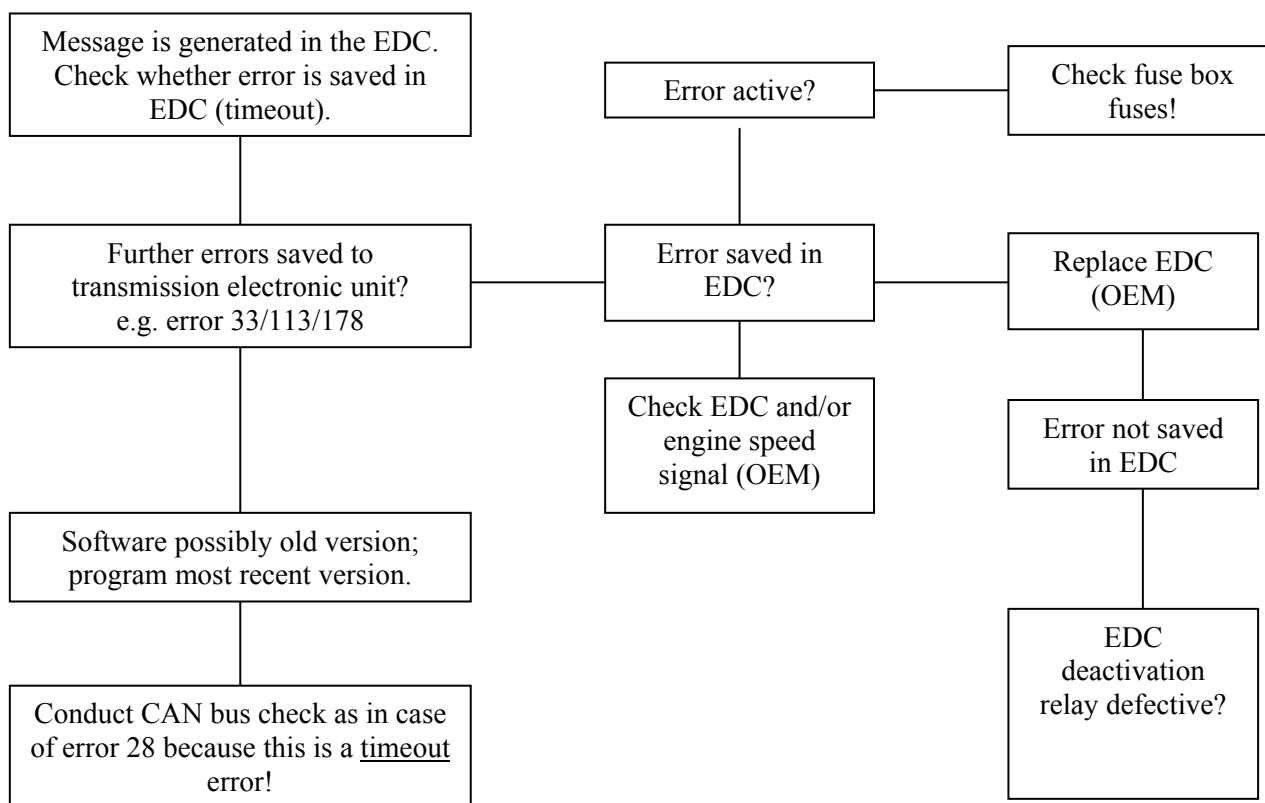
Iveco error number: 1A

Error description: CAN engine configuration timeout.

Error rectification:

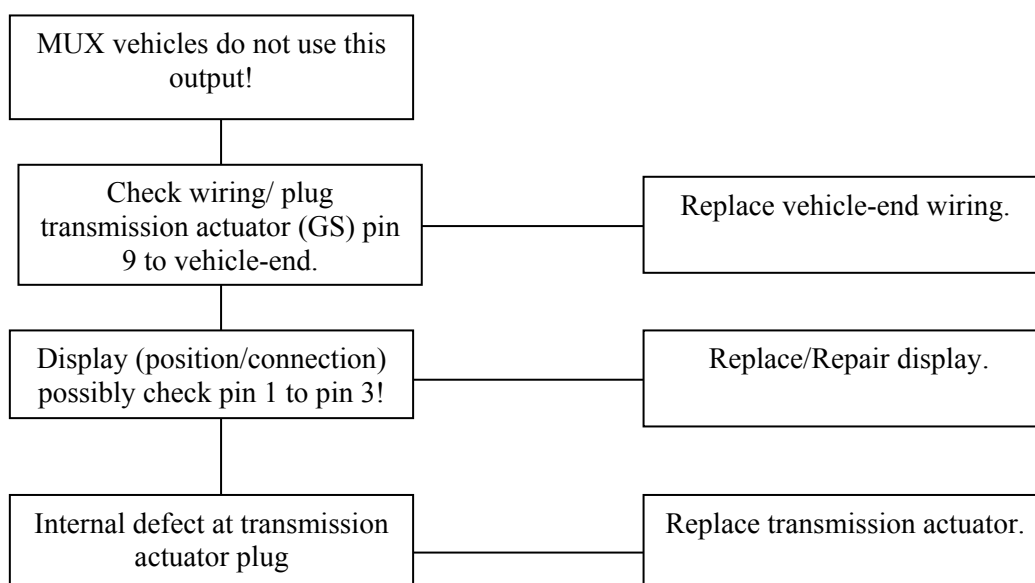
Iveco error number: 59

Error description: Short circuit to plus (+) at SD (digital signal) output to display.

Error rectification:

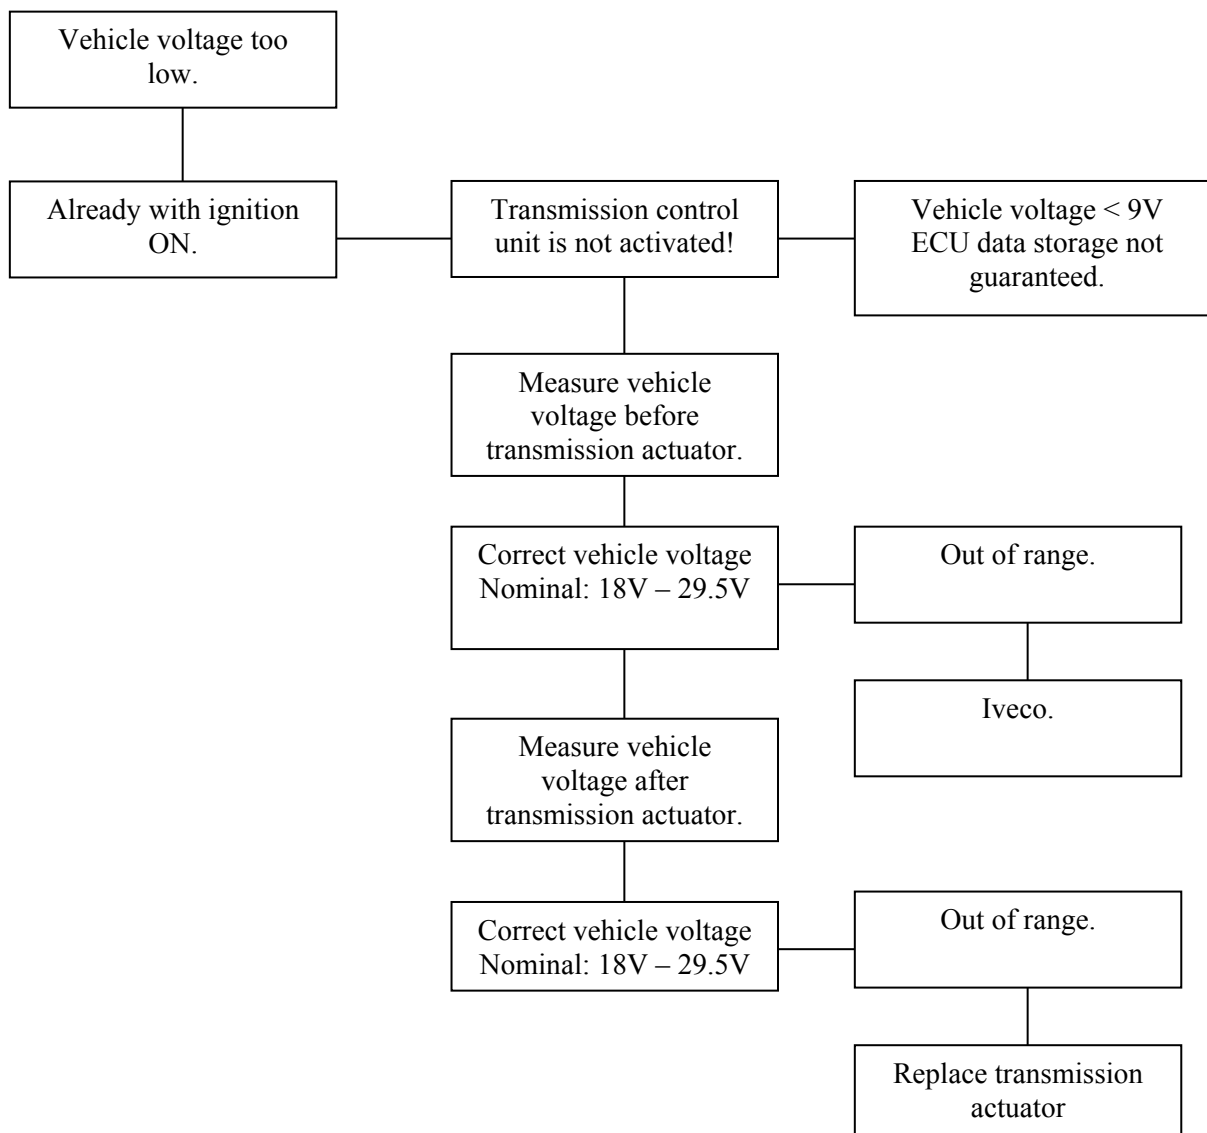
Error rectification:

System response: During travel and if the vehicle is at a standstill, gear shifts are inhibited. If a gear is engaged and the driver switches off the ignition, the control unit tries to shift to neutral. The automatic unit is deactivated after a certain period of time. If a PTO is activated and the corresponding relay cannot be connected, the PTO is deactivated. Follow-up errors, due to undervoltage are not displayed.

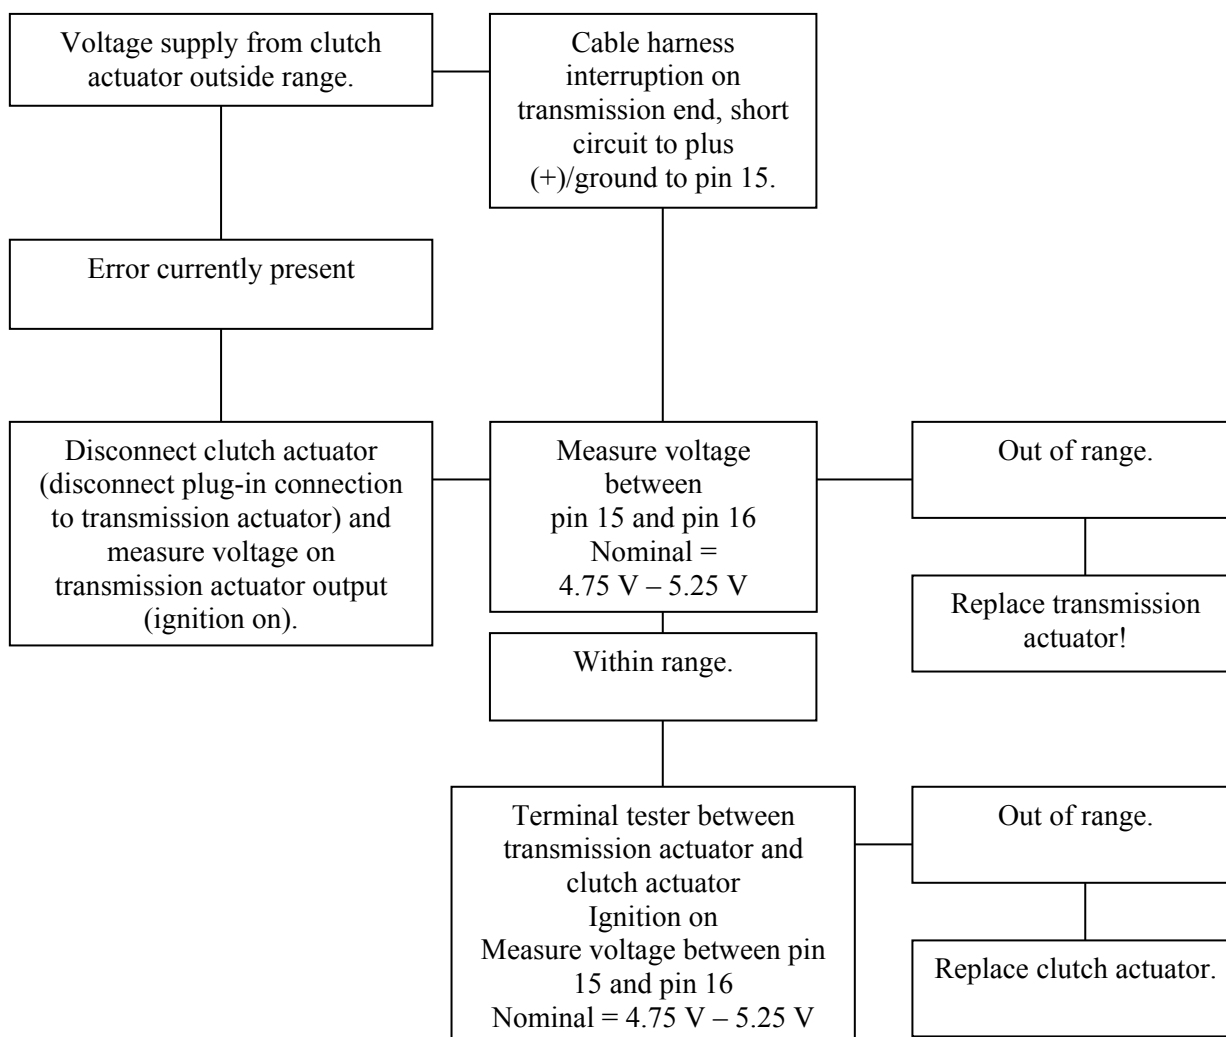
Error rectification:

Iveco error number: **6B**

Error description: Faulty voltage supply of the clutch travel sensor (AU output).

Error detection: Voltage outside range.

System response: The automatic shift unit is deactivated. During travel, the clutch is opened and closed in a time-controlled manner. Maneuvering not possible. If the vehicle does not set off within a certain amount of time, the transmission automatically shifts to neutral. The new starting gear must be selected using the range selector. Vehicle setting off is difficult and jerky!

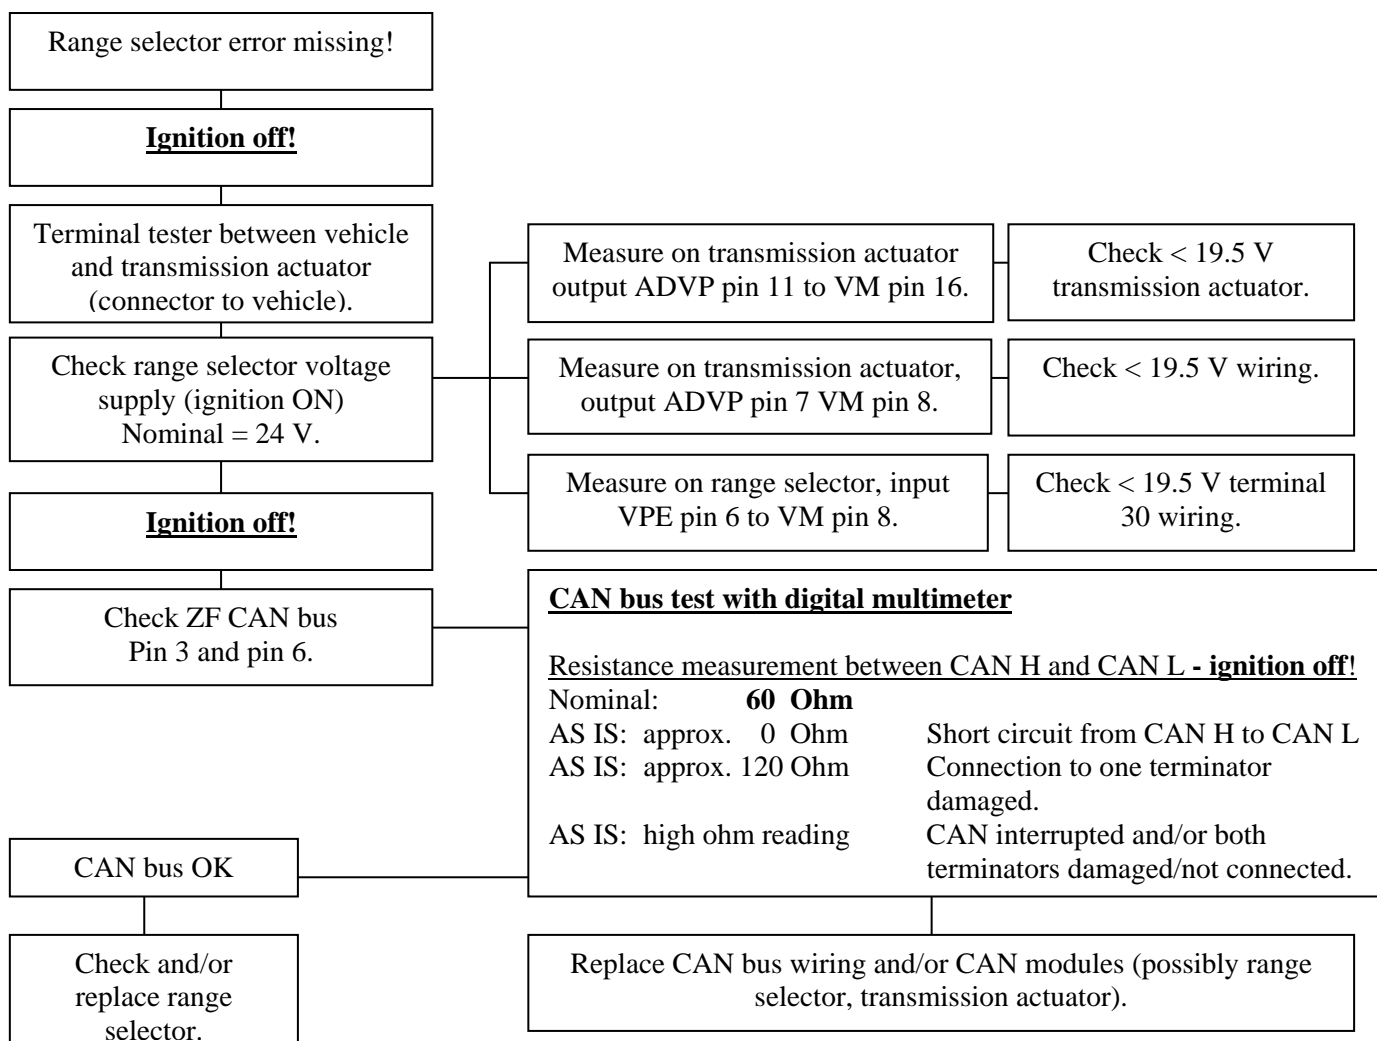
Error rectification:

Iveco error number: 6C

Error description: Range selector error

Error detection: Through switch plausibility check in range selector.

System response: Control lever: No shifting possible during travel. At standstill the "last starting gear" is selected in the manual mode (half-automatic mode), the automatic starting gear in automatic mode. If neutral is activated or existing at standstill, the starting gear is not engaged.
Neutral switch: No shifting possible during travel. At standstill a starting gear can be selected and the vehicle can be driven with a starting gear selected.
R gear selector signals: If there is a fault (no signal) in one of the two Reverse gear switches at a standstill and if the tip-action speed range selector is pulled backwards (-/--), the low-ratio Reverse gear (RL) is engaged.

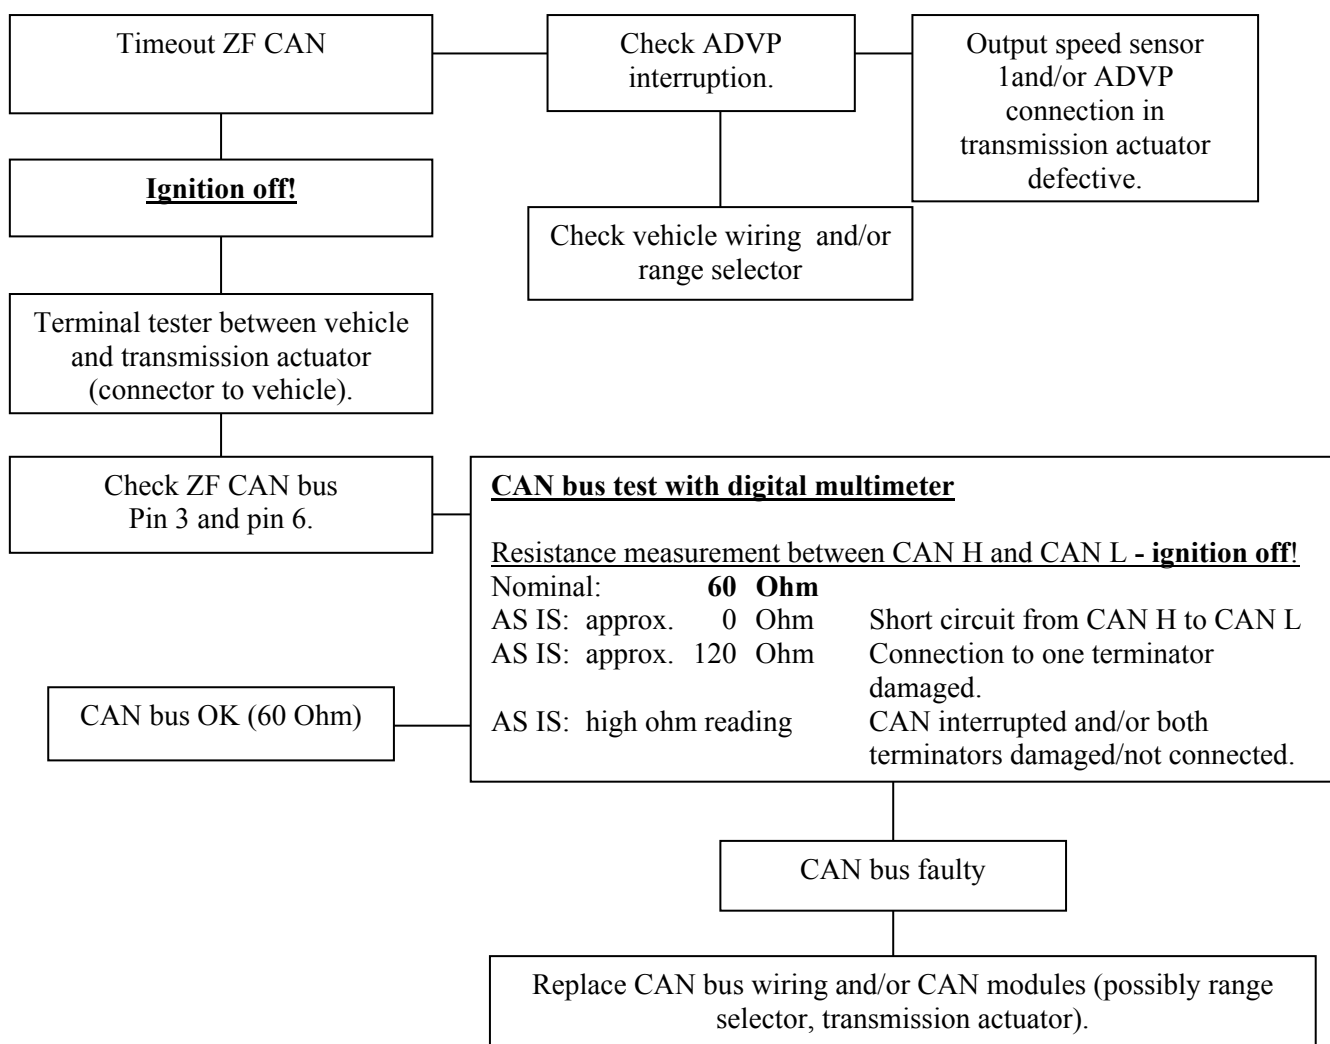
Error rectification:

Iveco error number: **6E**

Error description: ZF CAN Timeout

Error detection: ZF-CAN information can neither be sent nor received.

System response: If the error is detected with ignition ON, the system is not available. While driving, gear shifting is not possible. If vehicle comes to a standstill, the last starting gear selected (with the rotary switch) is engaged. Further driving possible only with starting gear. If reverse gear is selected, the transmission automatically shifts to neutral. No range selector message. System not available!

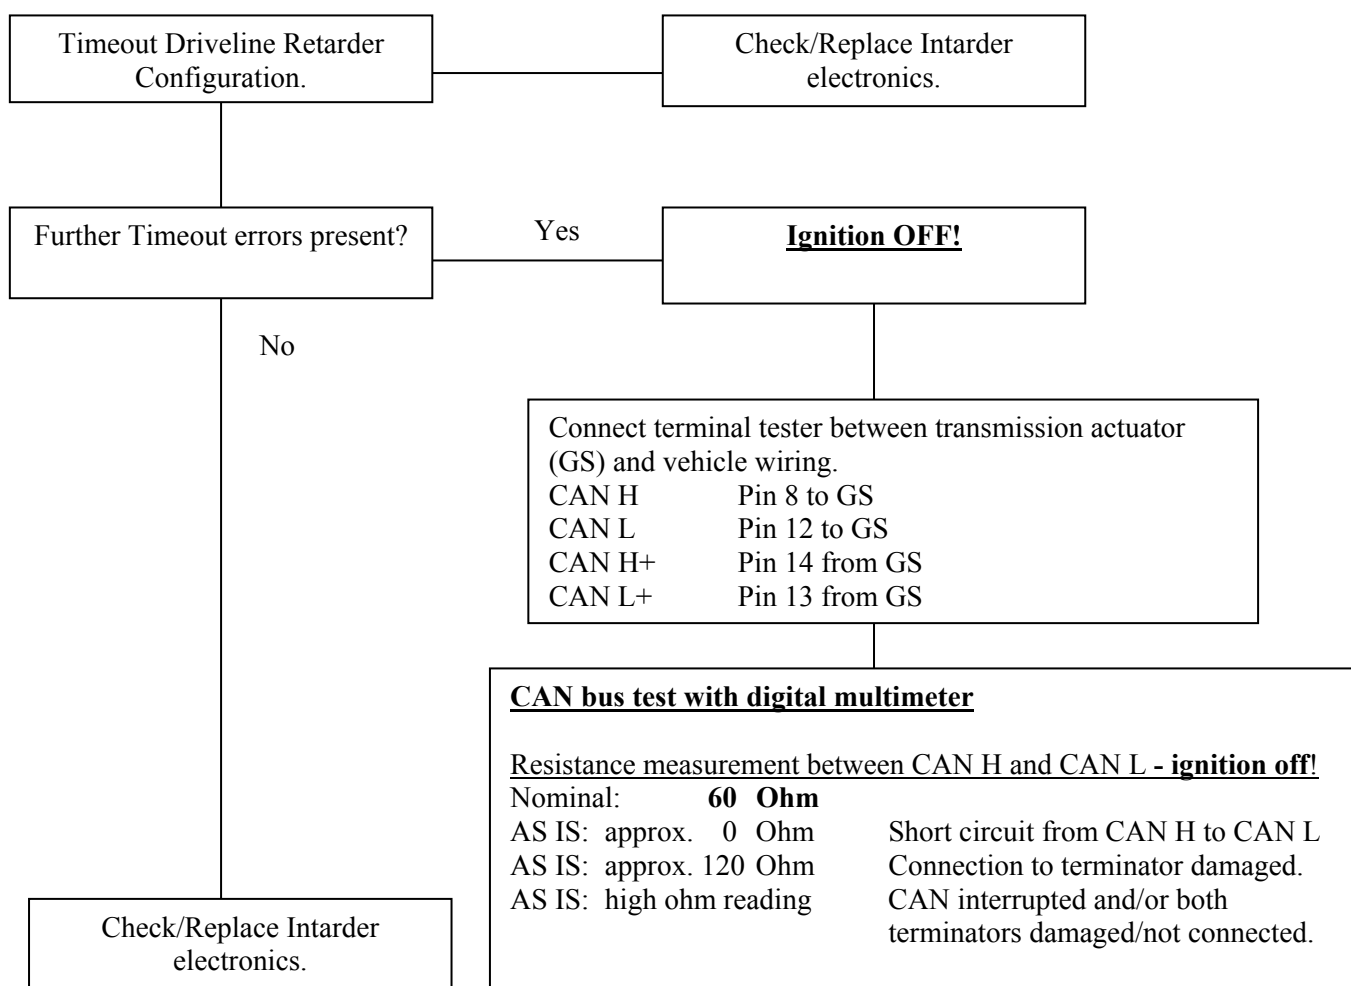
Error rectification:

Iveco error number: 71

Error description: CAN "Driveline Retarder configuration" timeout.

Error detection: An error is set after the message timeout.

System response: The automatic unit is no longer available. Manual shifting still possible.
If vehicle comes to a standstill, mid-starting gear is selected.
No other functional restrictions.

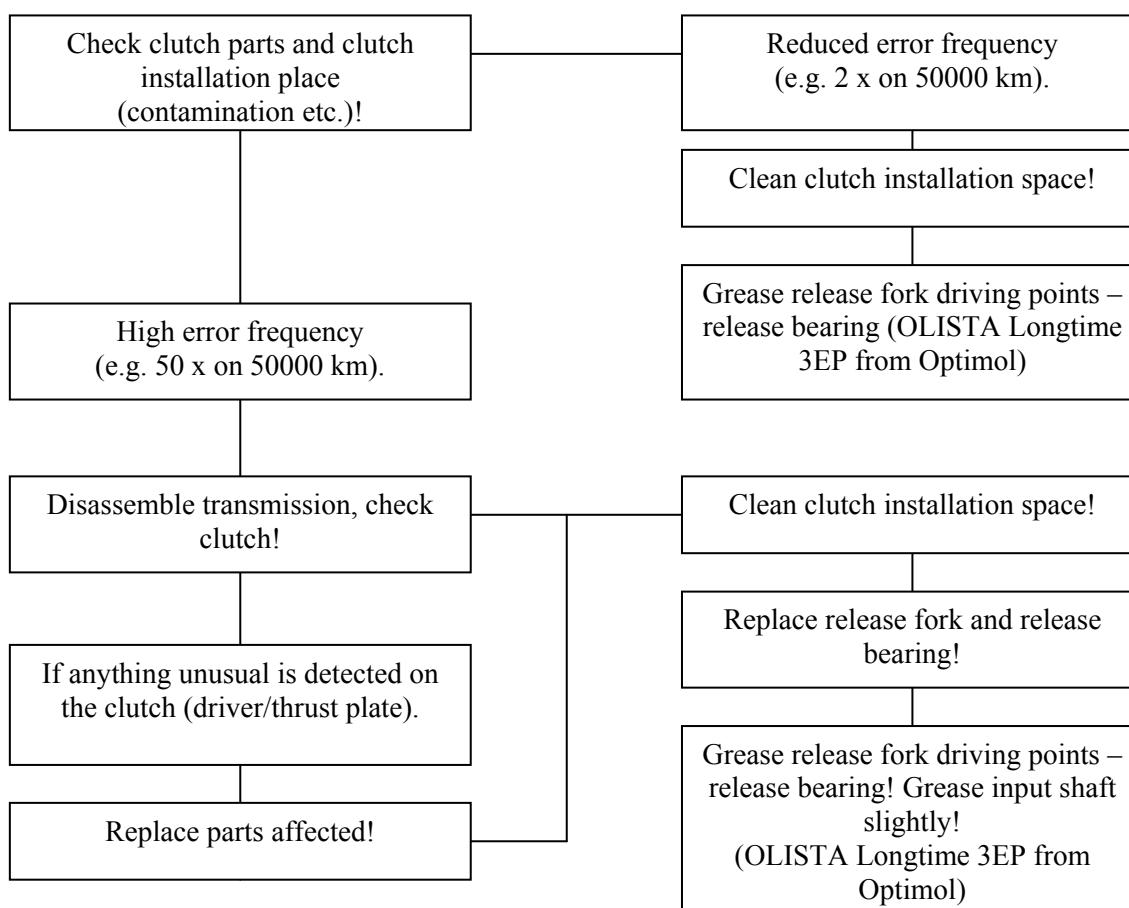
Error rectification:

Iveco error number: 72

Error description: Clutch closes accidentally when vehicle is stationary with gear engaged.

Error detection: At standstill and gear engaged, clutch closing!

System response: When vehicle stops, shifting is effected to neutral. No further system restrictions.

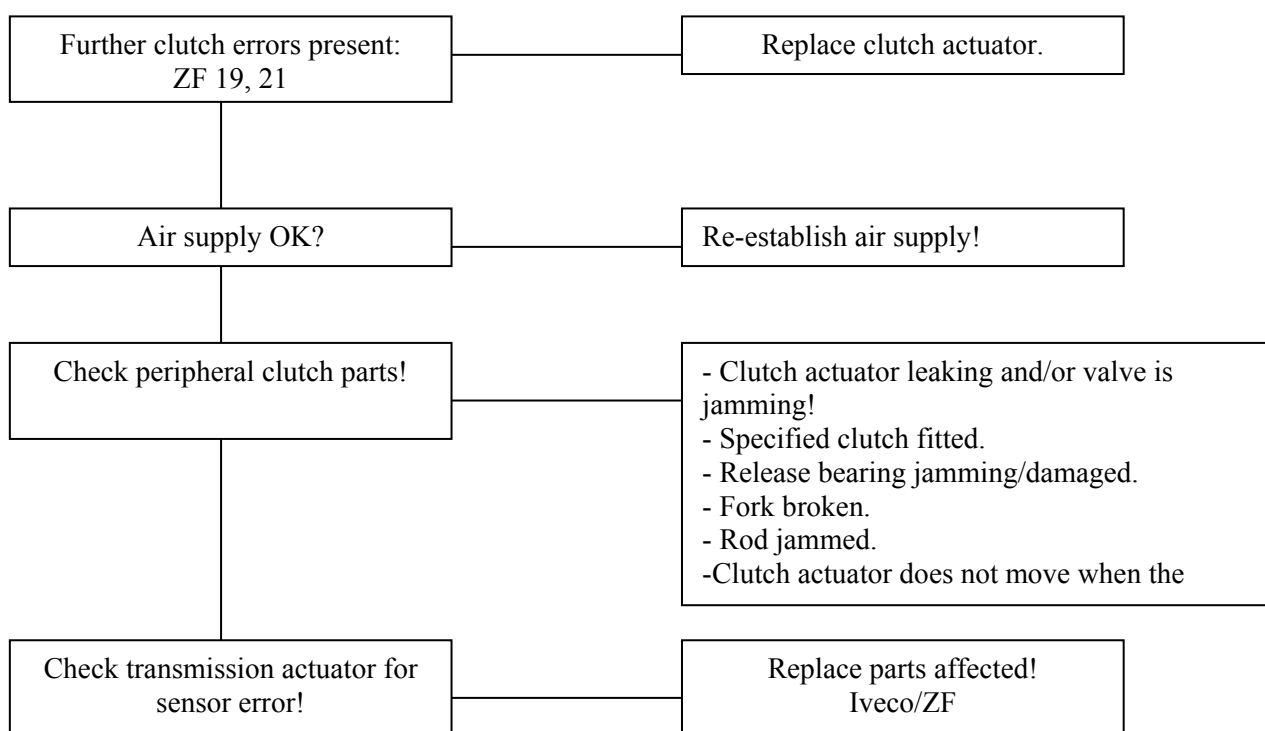
Error rectification:

Iveco error number: 77

Error description: Clutch not closing/not transferring engine torque.

Error detection: Clutch sensor does not detect closing. Engine speed is unlike input speed.
Condition: No clutch travel sensor error (ZF 124), no engine speed error (ZF 97), no input speed error (ZF 98).

System response: During driving, gear shifts are inhibited. If the vehicle comes to a standstill, attempts are made to open the clutch. When vehicle stops, neutral position is automatically engaged. Other gear shifts not possible. System not available.

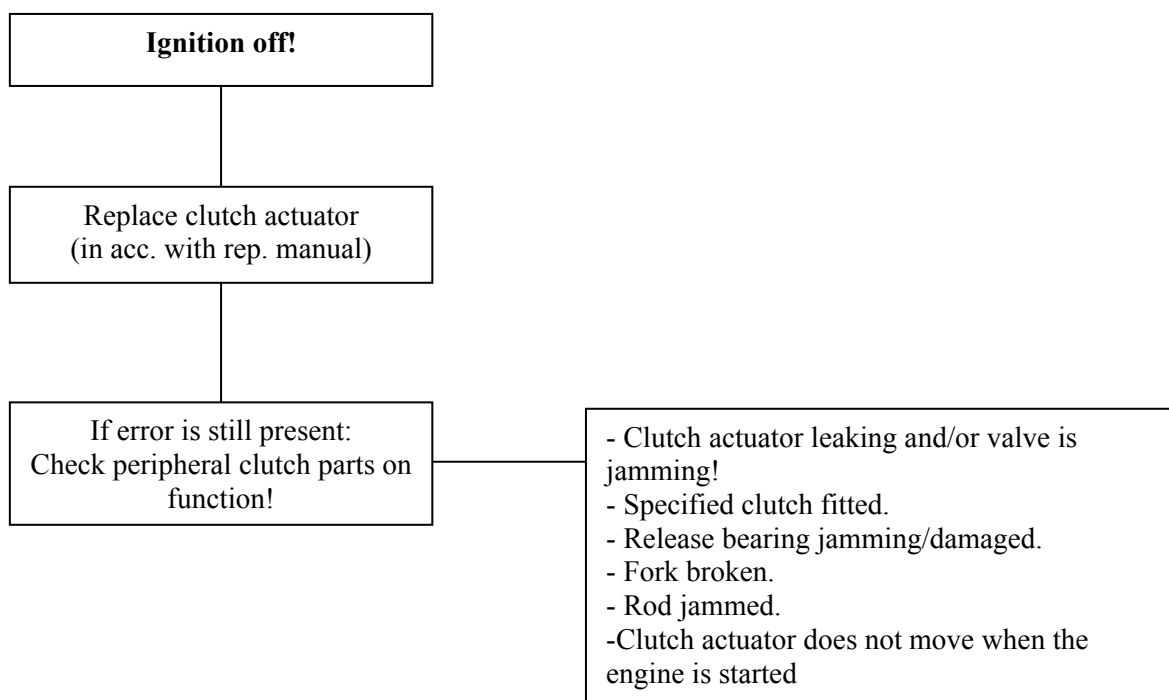
Error rectification:

Iveco error number: 78, 79, 7A, 7B

Error description: Mechanical error on clutch actuator valve:
Y17 valve, clutch slowly opening (error 120),
Y15 valve, clutch slowly closing (error 122),
Y16 valve, clutch quickly opening (error 121),
Y14 valve, clutch quickly closing (error 123).

Error detection: Clutch does not open/close although valves have been activated.

System response: The automatic unit is not available. Manual shifting possible.
If one valve fails, this function is adopted by the other Close/Open valve.
Reduced comfort when maneuvering and starting. If both closing and opening valves fail, the system is not available.

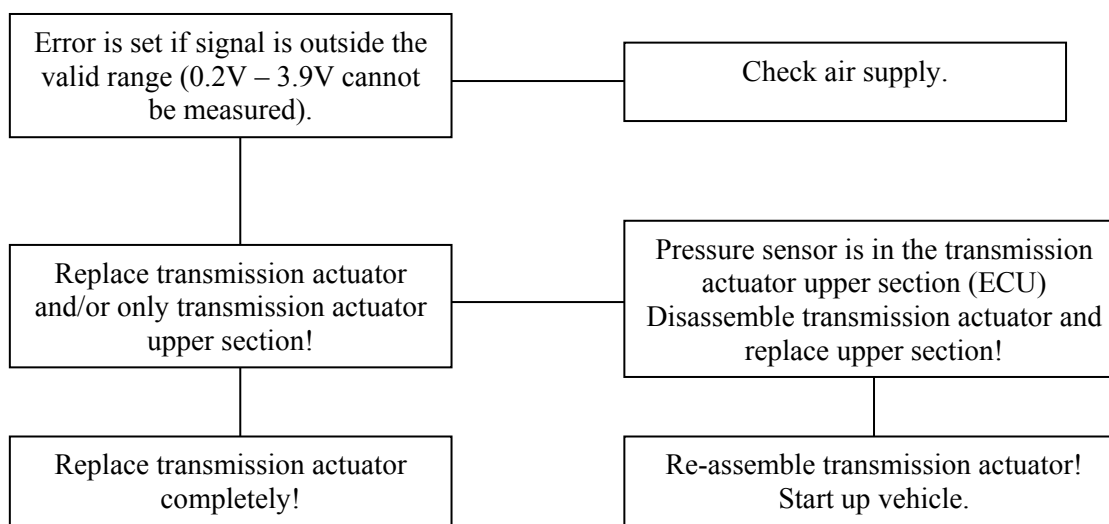
Error rectification:

Iveco error number: 7E

Error description: Signal error pressure sensor

Error detection: Voltage on analogue input outside range!

System response: The system function is not restricted if the external air supply is sufficient. In the case that there is too less atmospheric pressure, "AL" compressed air indicator is not shown on the display.
The teach-in process after ignition ON of transmission and clutch is conducted in a time-dependent manner. The teach-in time could last some more time. The automatic unit is not available!

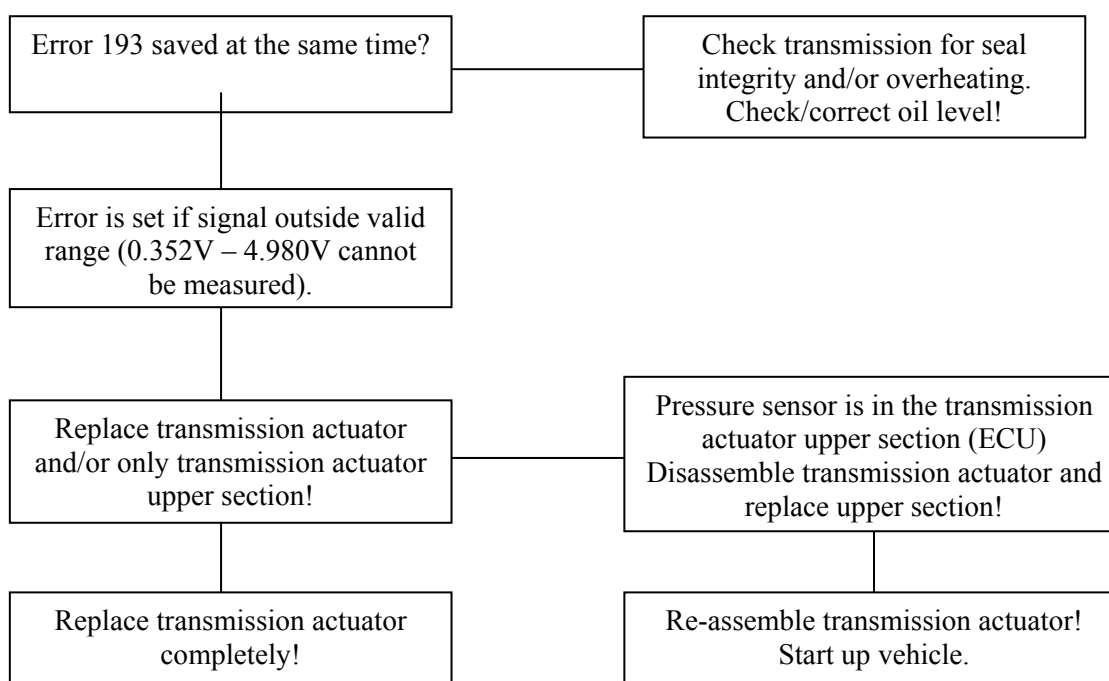
Error rectification:

Iveco error number: 7F

Error description: Signal error ECU temperature.

Error detection: Voltage level outside range.

System response: The automatic unit is not available. Manual shifting possible. No further system impairments.

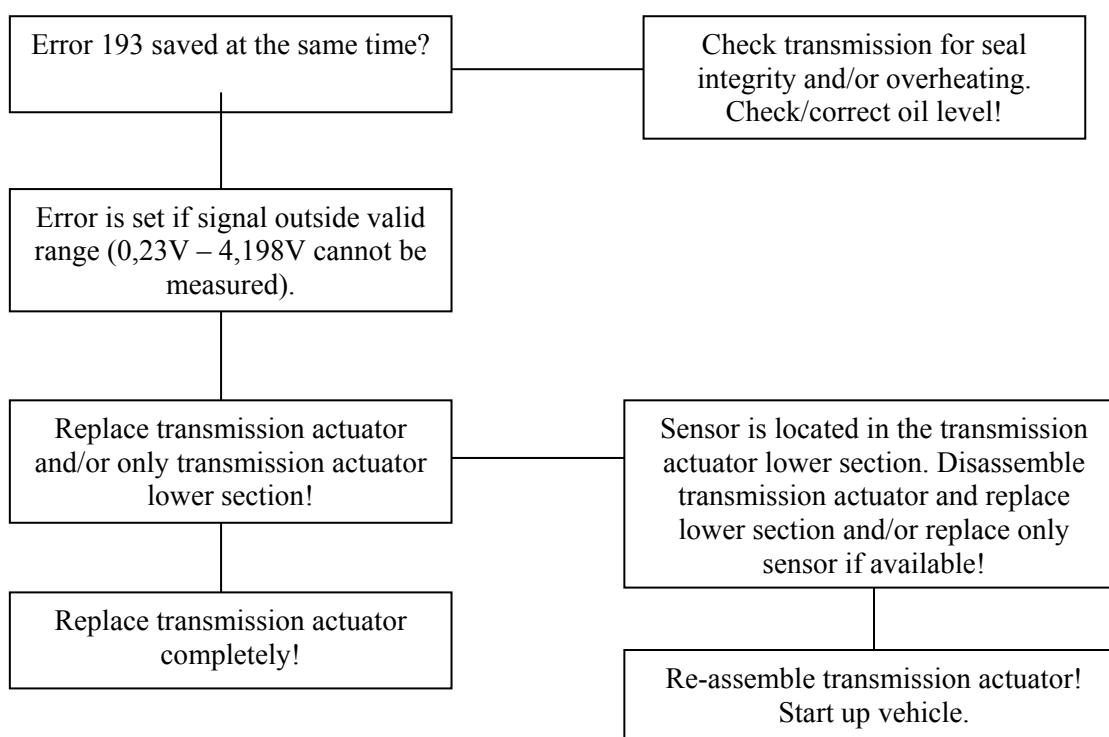
Error rectification:

Iveco error number: 80

Error description: Signal error oil temperature sensor.

Error detection: Voltage level outside range.
(ADC_Öl_Temp_Ausfall between 0.23V and 4.198V).

System response: No further system impairments.

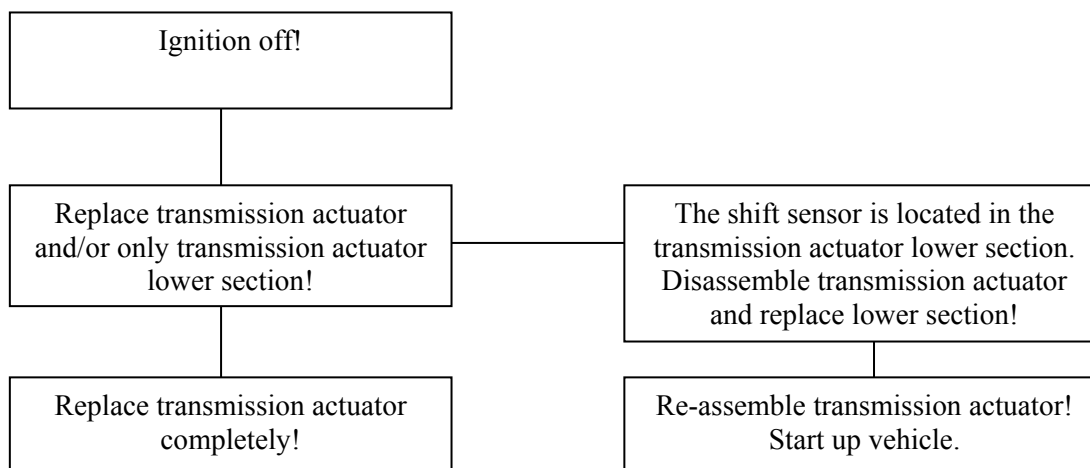
Error rectification:

Iveco error number: 81, 82, 83

Error description: No shift sensor signal present.
Error 129 Short circuit to plus (+).
Error 130 Short circuit to ground/earth.
Error 131 Interruption.

Error detection: By ECU hardware.

System response: If the error occurs during travel when shifting, gear shifts are inhibited. Shifts can only be made out of neutral. If the vehicle is at a standstill, starting gears can be selected.

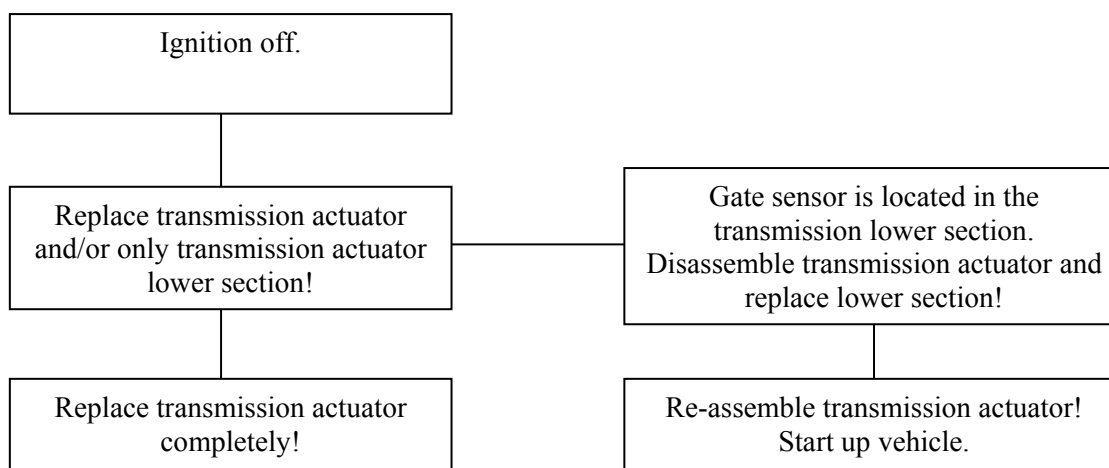
Error rectification:

Iveco error number: 85, 86, 87

System response: During travel only forwards gears which are opposite to the shift direction for the reverse gear can be selected. If an error occurs during the shift, the target gate is engaged in a time-controlled manner. When the vehicle is at a standstill all permitted starting gears which shift direction is opposite to the reverse gear can be selected. Reverse gear cannot be selected.

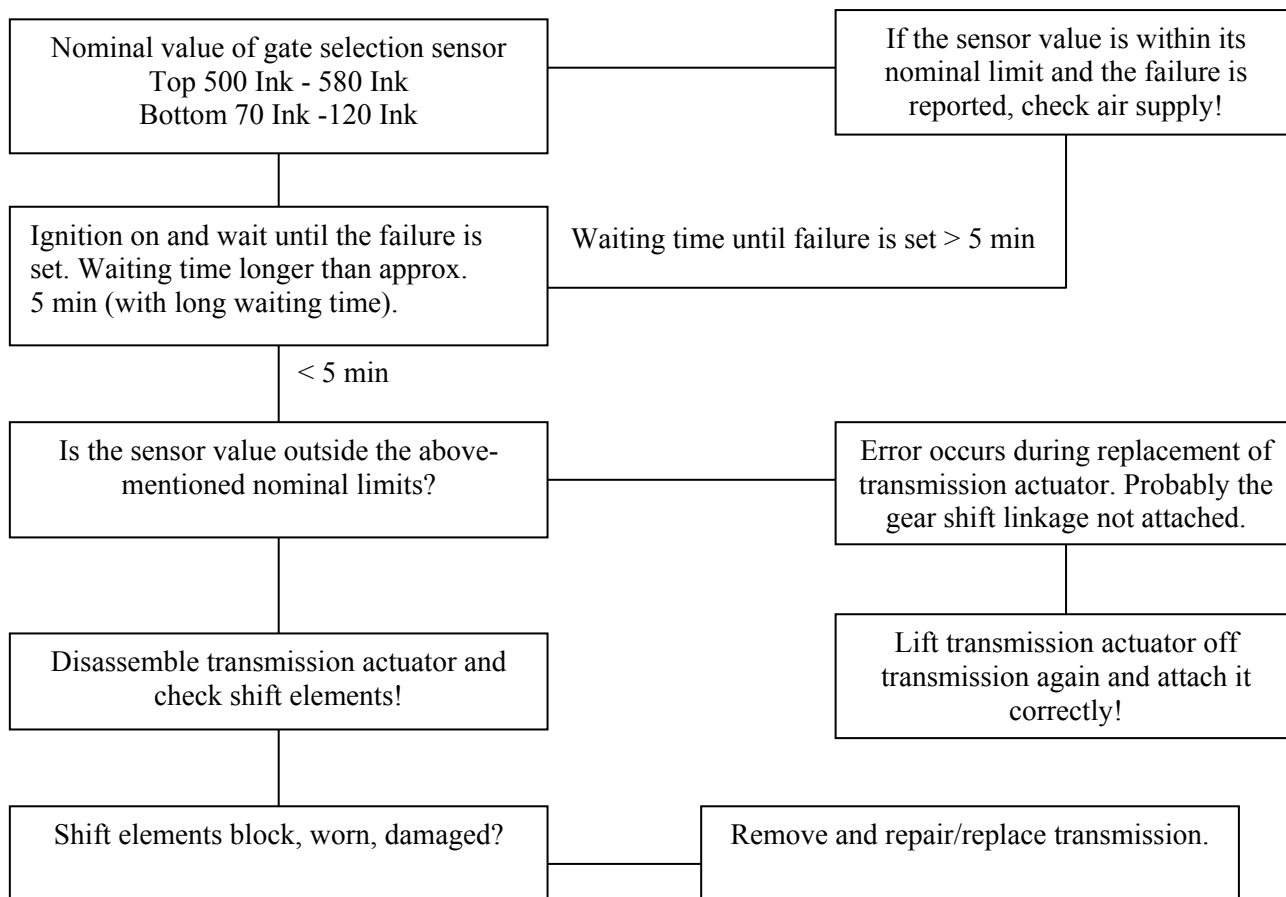
Error rectification:

Iveco error number: 88

Error detection: Sensor value outside teach-in range and teach-in process failed with sufficient air pressure and after three attempts.
Sensor value outside of the teach-in range and teach-in process failed with insufficient air pressure after a certain waiting time and after a max. number of attempts.

System response: In the case of an electrical error on the selection valve only the possible gate is taught in.
Upper forward gears: 10/12 gear => gate 2/3, 16 gear => gate 3/4
Lower forward gears: 10/12 gear => gate R/1, 16 gear => gate 1/2
ECU tries to teach-in the gate of the upper forward gears of the main transmission. In the case of no success, attempts are made to teach-in the gate of the lower forward gears. In the case that both cannot be taught in, a teach-in error of the gate is set. If there is insufficient air and/or a pressure sensor signal error (ZF error 126), this teach-in attempt is repeated now and again.

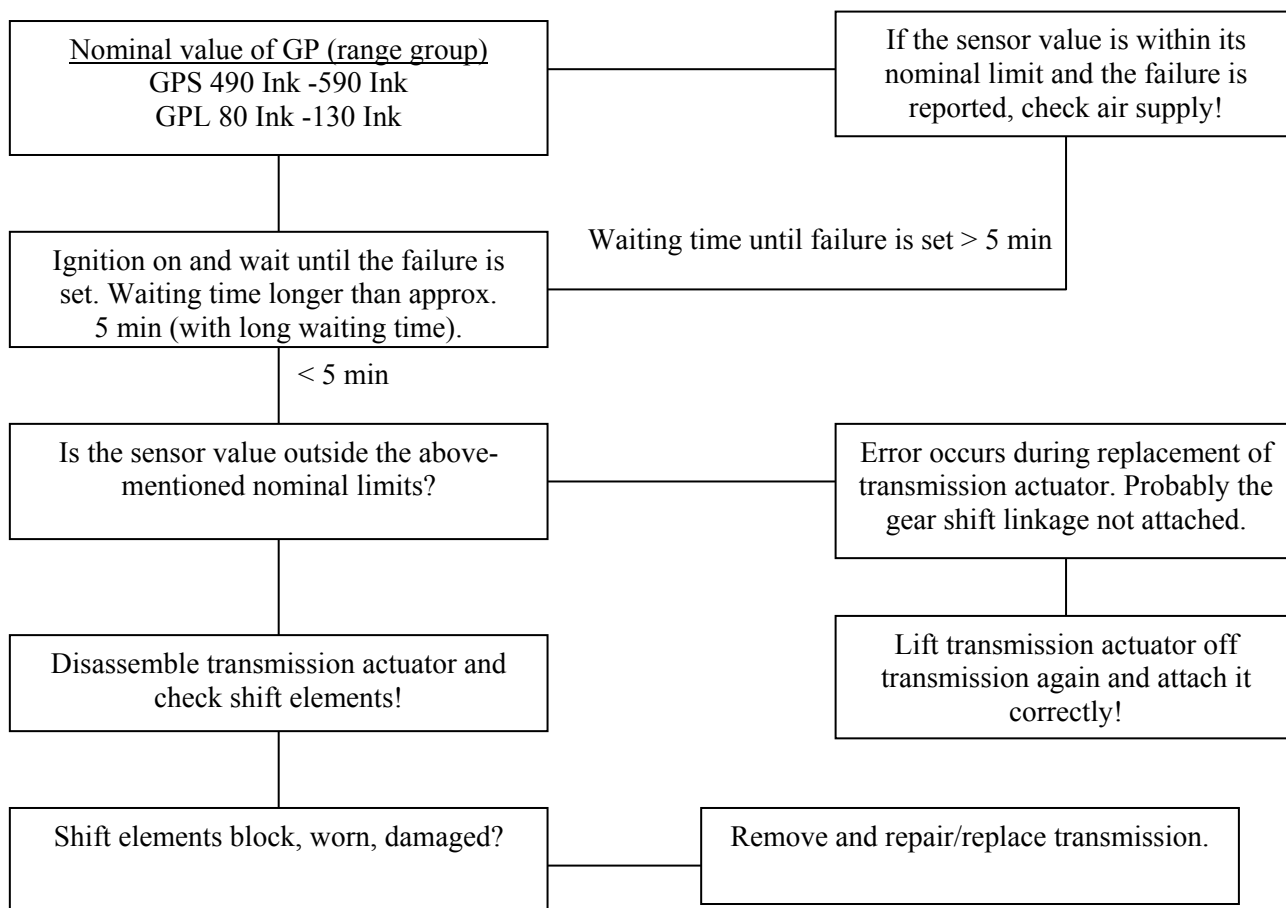
Error rectification:

Iveco error number: 8C

System response: With ignition OFF the GP remains in the last setting selected. When the ignition is switched ON, attempts are made to teach-in GP-high. If this cannot be done after several attempts, attempts are made to teach-in GP-low. If neither GP-high nor low can be taught in, a teach-in error is set. The system is not available! If there is insufficient air and/or a pressure sensor signal error (ZF error 126), this teach-in attempt is repeated now and again.
