Failure tree

IVECO

Edition: 2004-02
SW31_13e

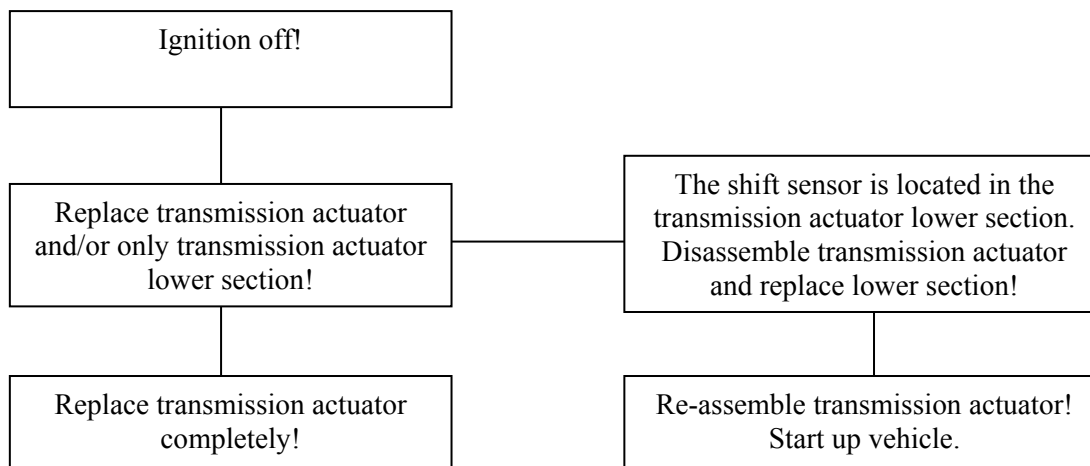
Error rectification:

Iveco error number: 8D, 8E, 8F

System response: If the error occurs during travel when shifting, GV shifts are inhibited. Further driving only possible with the last selected GV (splitter group) position. The automatic shift unit is deactivated.

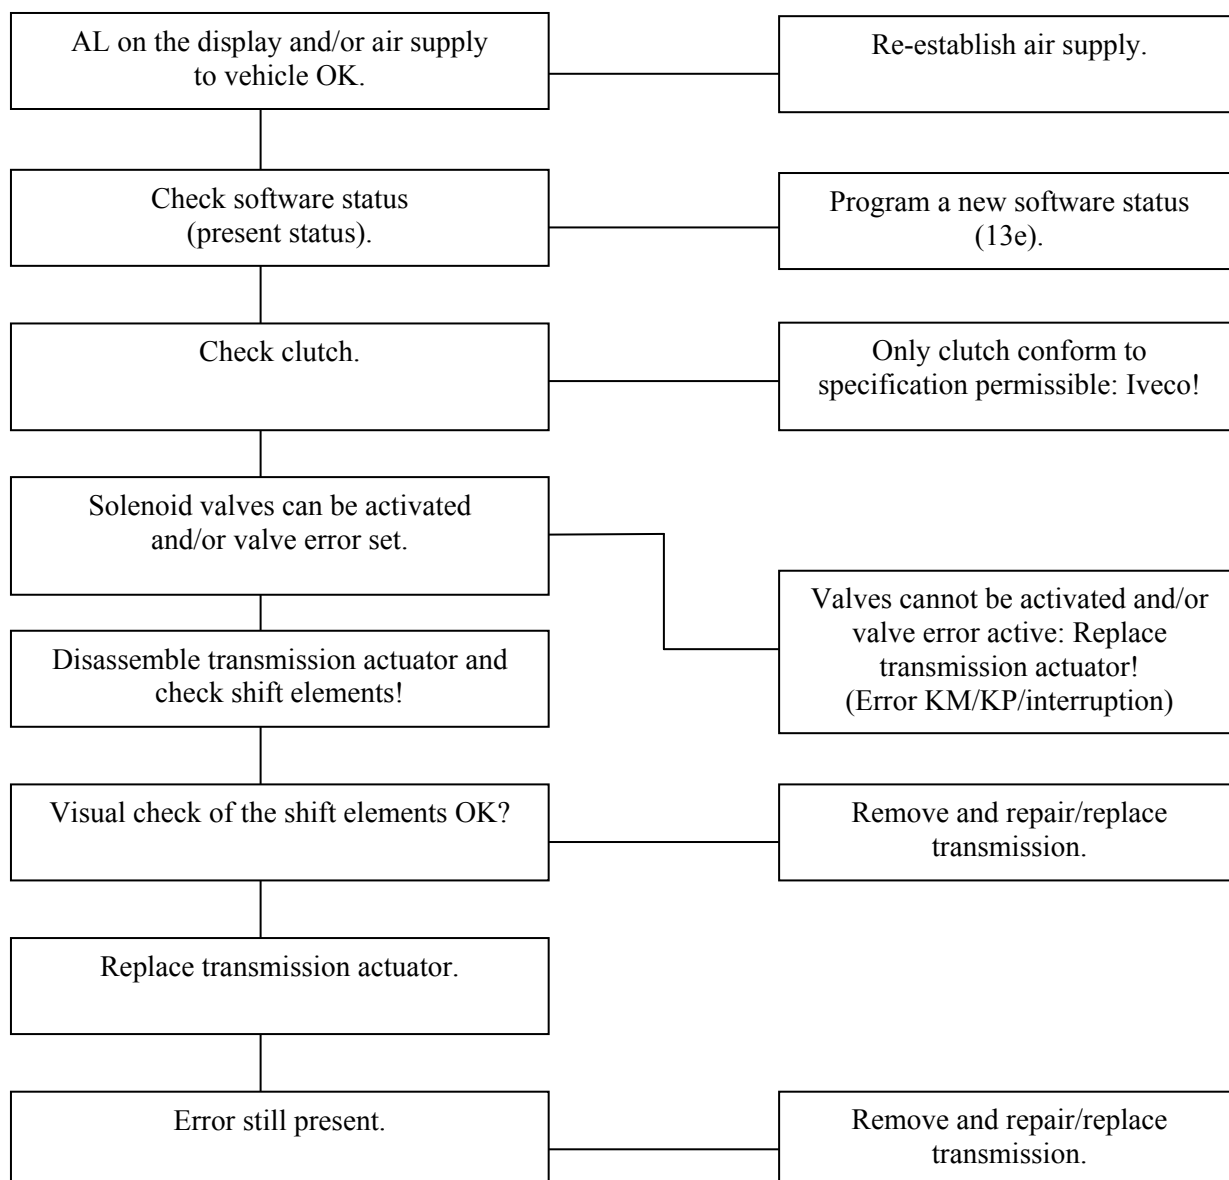
Error rectification:

Iveco error number: 92

System response: The automatic shift unit is deactivated. If the GP position requested cannot be selected, the GP cylinder tries to shift three times. If the GP position requested cannot be selected, the following gear is selected:
When shifting from GPL to GPS, the highest gear in GPL is selected. When shifting from GPS to GPL, the lowest gear in GPS is selected. If the vehicle is at a standstill and GPL cannot be selected, the lowest gear in GPS is selected as starting gear.

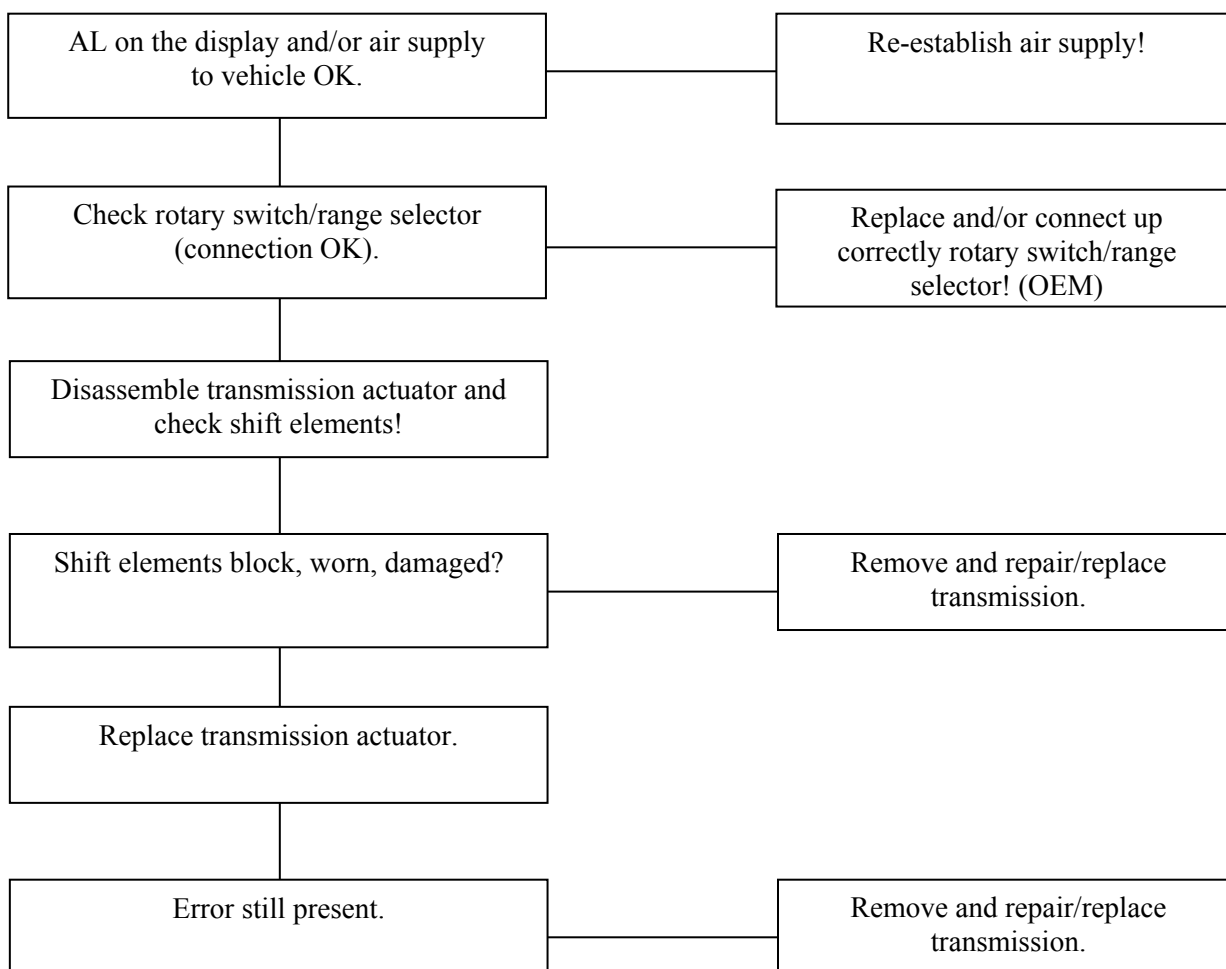
Error rectification:

Iveco error number: 9C

System response: The automatic shift unit is deactivated. Automatic shift to neutral. Clutch remains opened if shifting to neutral is not possible. Repeated gear shifting must be triggered using range selector.

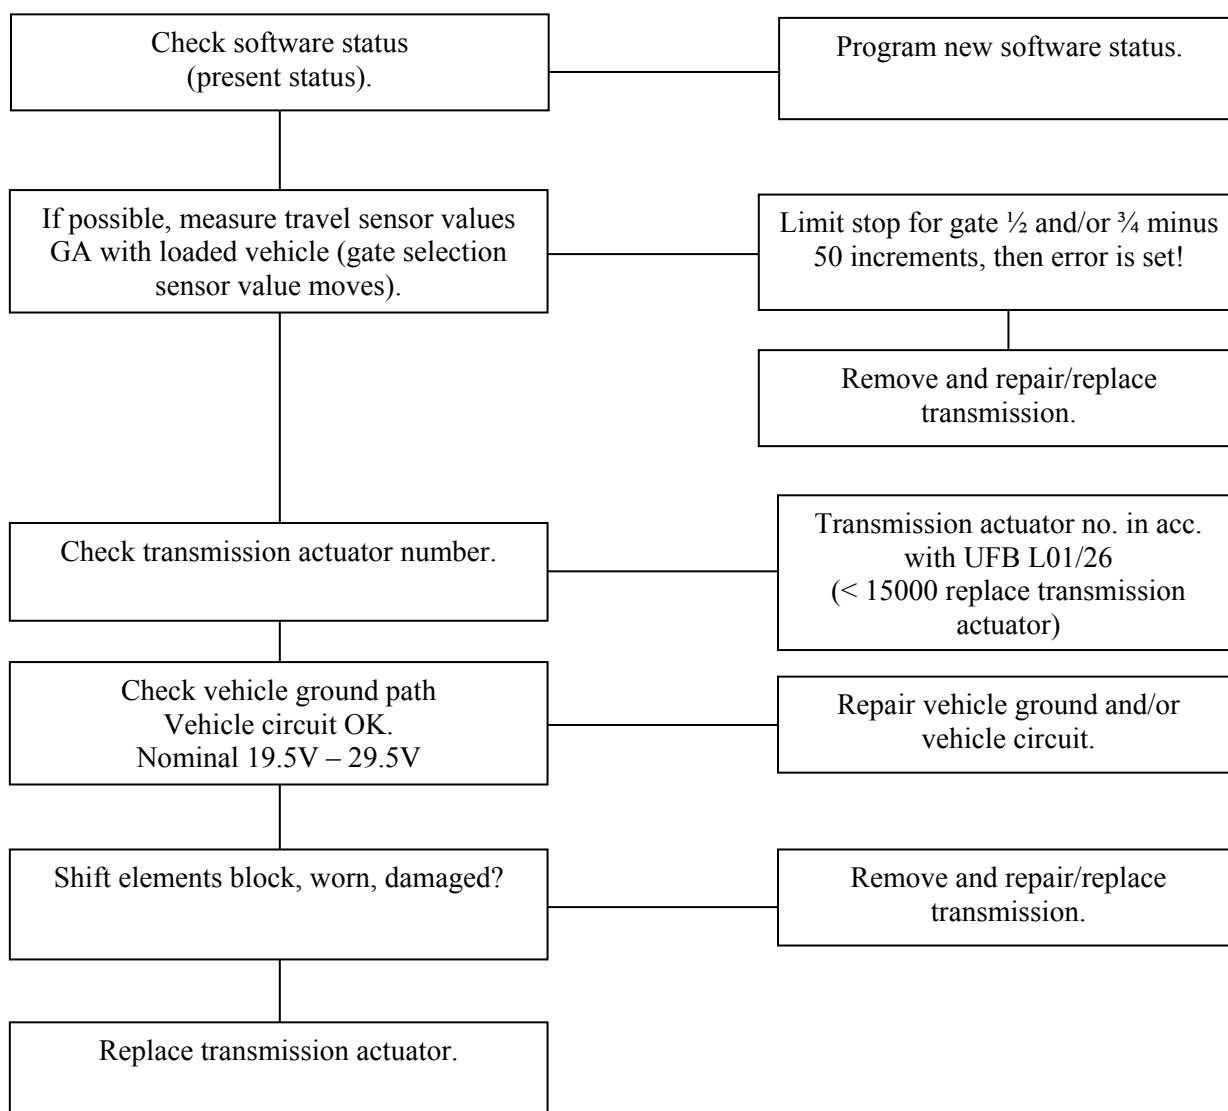
Error rectification:

Iveco error number: 9D

System response: The transmission attempts to shift the gear back into its limit position. If the gear has been completely deactivated, a suitable speed dependent gear is engaged automatically.

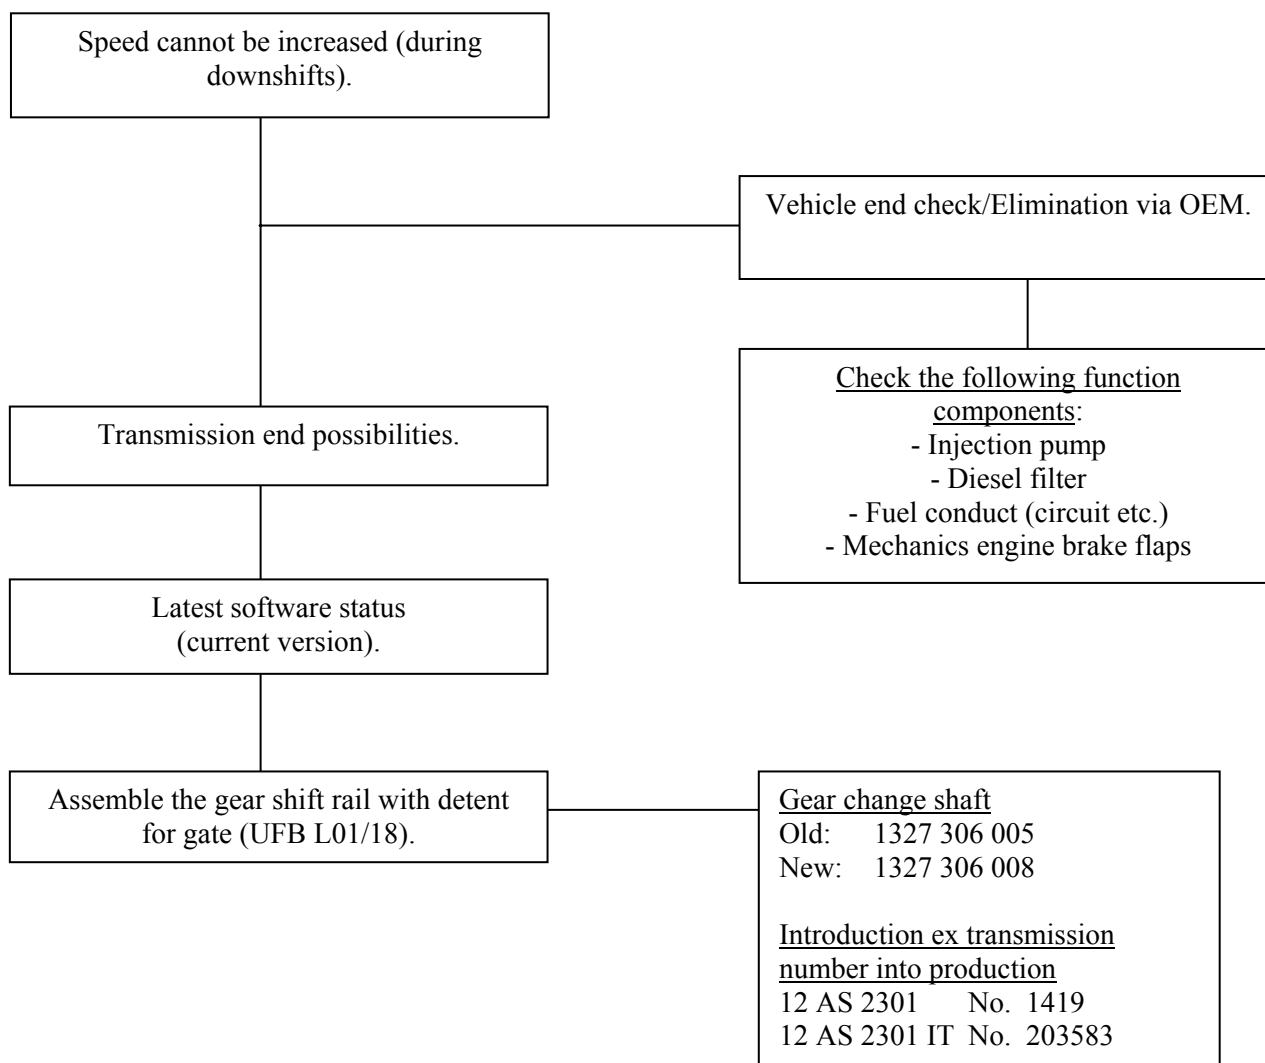
Error rectification:

Iveco error number: A3

Error description: Engine does not respond to torque action.

Error detection: No engine intervention (increase in engine speed) possible via CAN interface.

System response: During travel, gear shifts are blocked.
Setting off permissible. Clutch function and comfort are reduced.

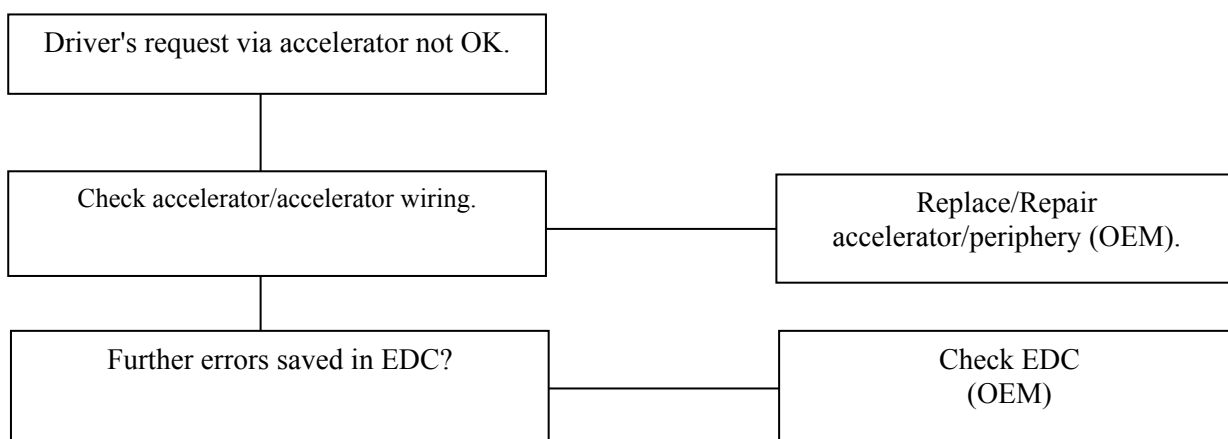
Error rectification:

Iveco error number: A4

Error description: Signal error engine torque (calculated injection volume in % by EDC) driver's request (Drivers demand engine percent torque signal).

Error detection: No signal or signal incorrect.

System response: The automatic unit is deactivated and cruise control operation not possible. Manual shifting is possible. The closing quality of the clutch may be reduced.
Once the clutch has been closed, the injection volume is approved by the EDC. This results in poor shift quality after shifting.
If vehicle comes to a standstill, mid-starting gear is selected. Setting off possible. No other functional restrictions.

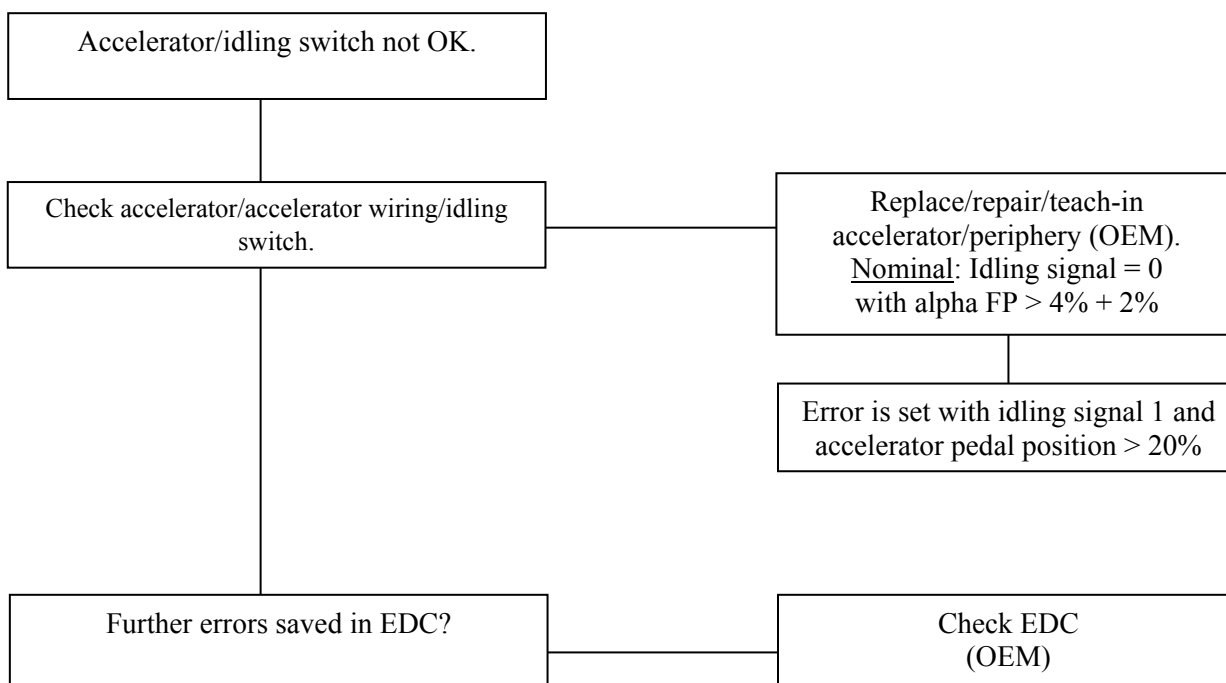
Error rectification:

Iveco error number: A6

Error description: Permanent idling signal.

Error detection: Accelerator position greater than coasting position and idling signal active.

System response: During travel automatic mode not available. Manual shifting permitted. If the vehicle comes to a standstill, maneuvering and setting off no longer possible. System not available.

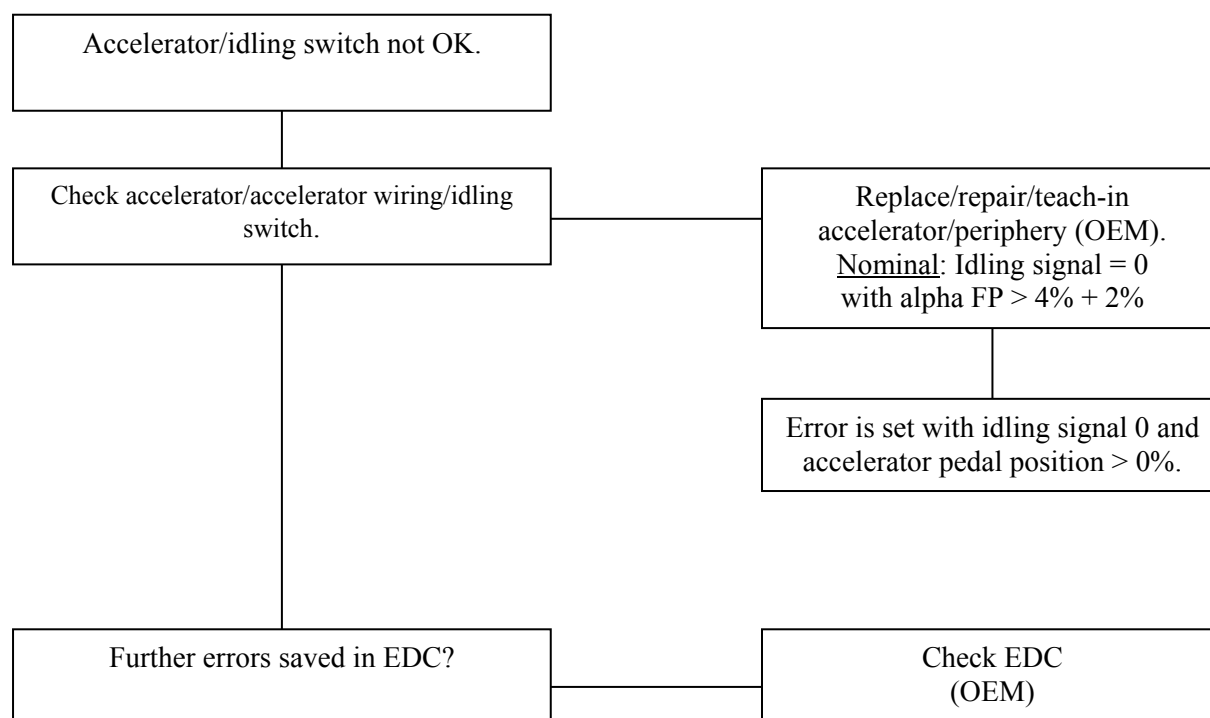
Error rectification:

Iveco error number: A8

System response: During travel, the automatic unit is deactivated, manual shifting is possible. After ignition OFF – ON (approx. 5 sec.), as long as the accelerator pedal value is in coasting mode (pedal not activated $\alpha_{fp} = 0\%$) and the idling signal is off, **AP** or **FP** appear on the display. If the idling signal does not appear within a determined time, an error is set and AP or FP disappears from the display. ECU checks the lower idling speed. Setting off is permitted once the verification check has been satisfied.

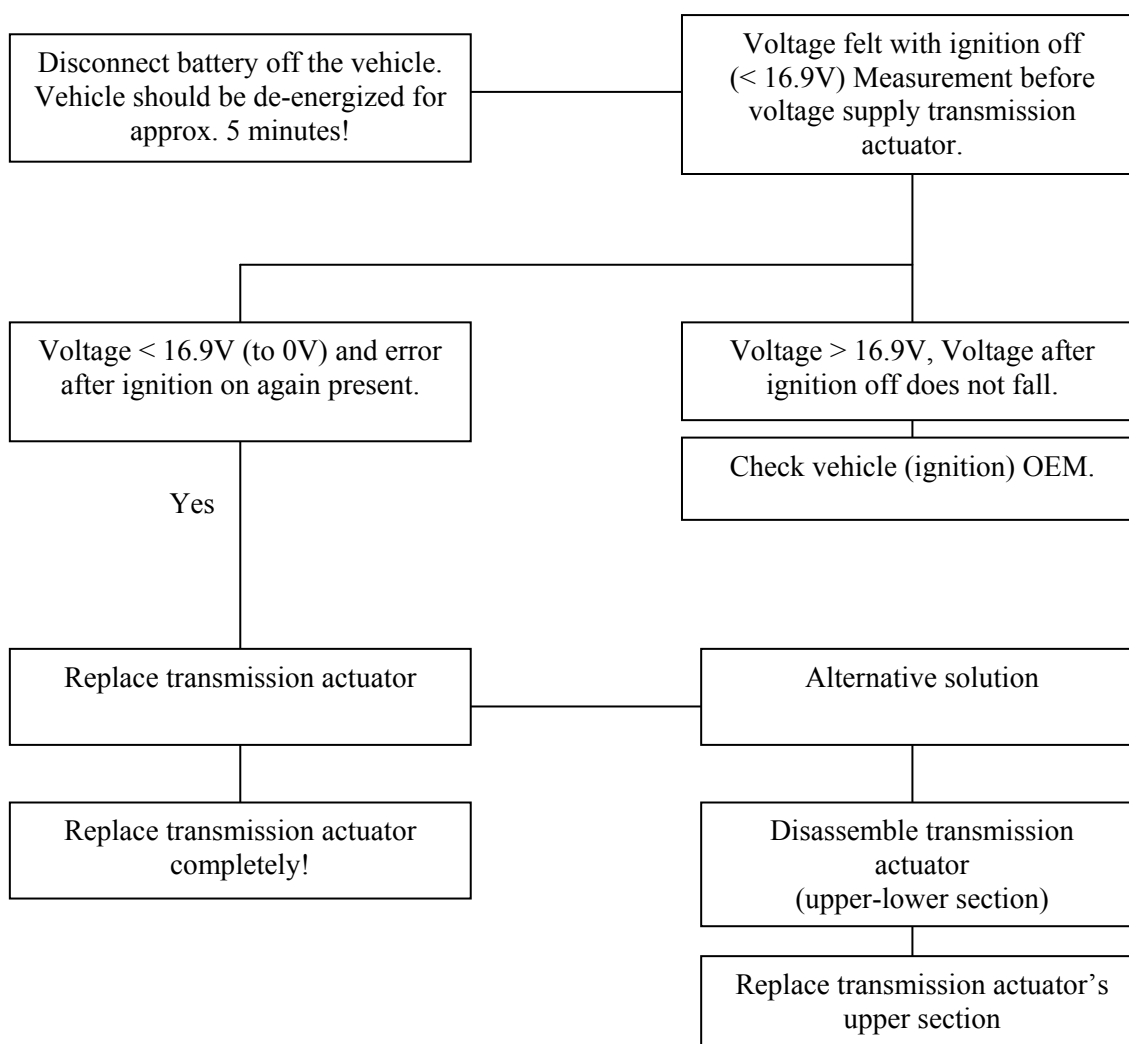
Error rectification:

Iveco error number: A9

System response: During driving, gear shifts are inhibited. The clutch opens as soon as the vehicle comes to a standstill. When vehicle stops, neutral position is automatically engaged. Other gear shifts not possible. System not available.

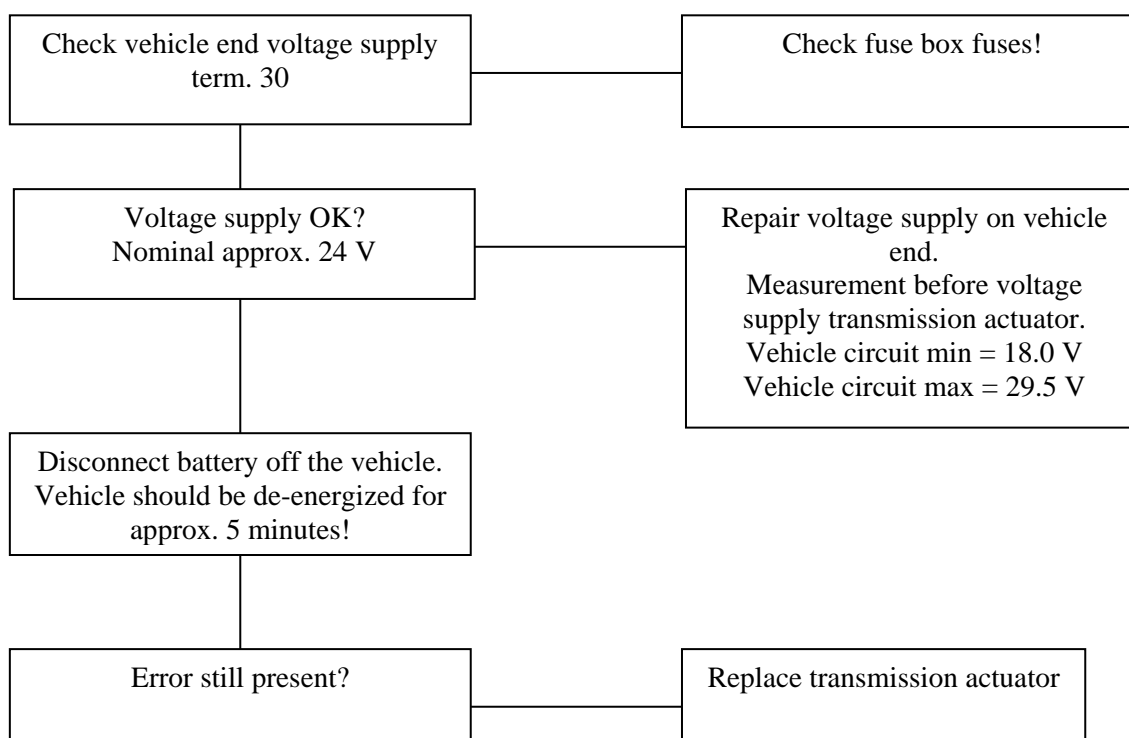
Error rectification:

Iveco error number: AA

System response: System not available. Clutch and transmission status are maintained.

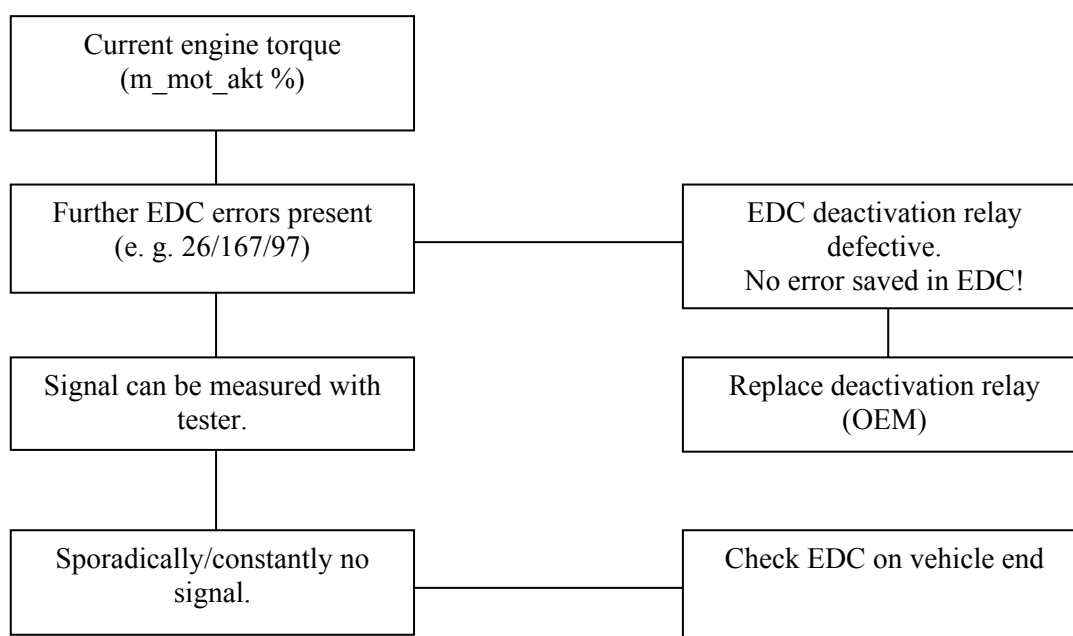
Error rectification:

Iveco error number: AB

System response: Automatic unit is deactivated, manual shifting is possible. The shift quality may be reduced. If vehicle comes to a standstill, mid-starting gear is selected. Setting off possible. “CL” clutch overload detection could appear earlier.

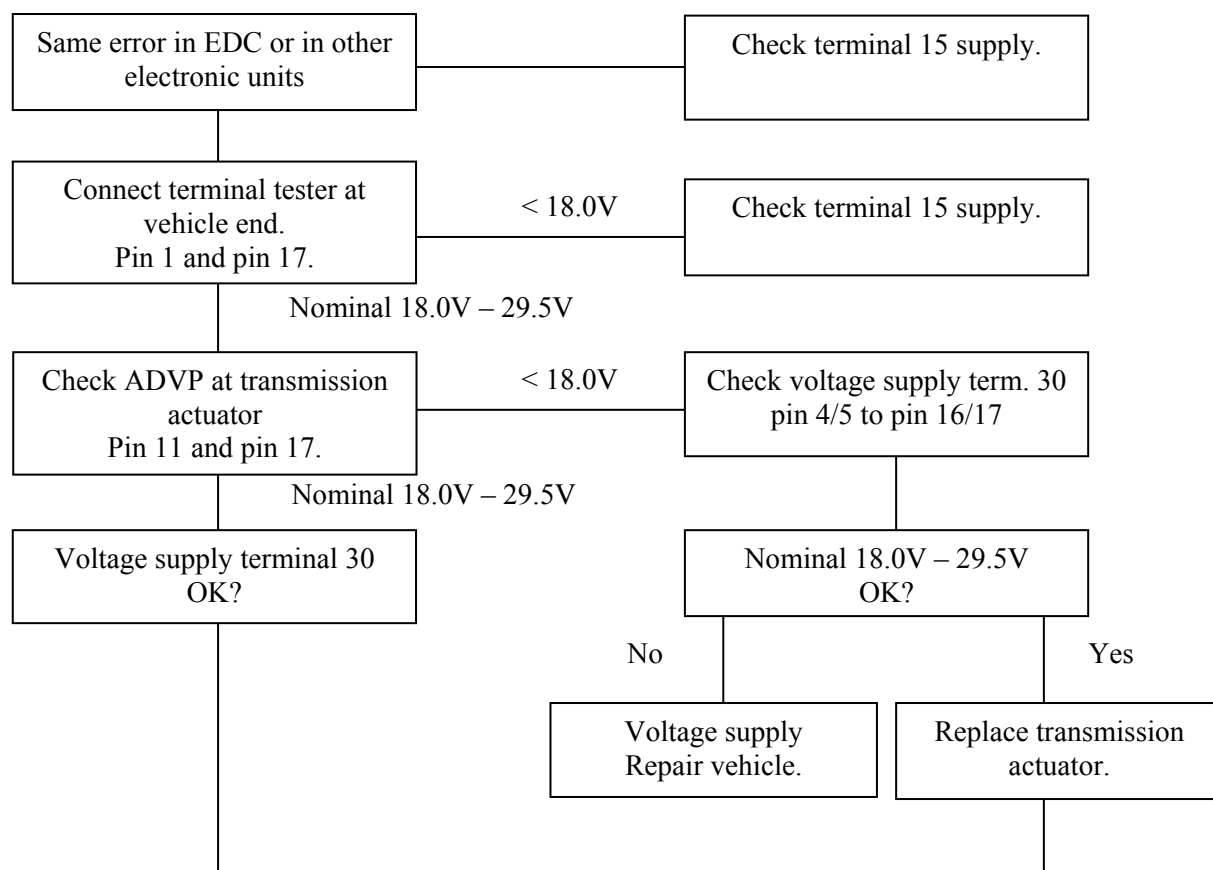
Error rectification:

Iveco error number: AF

System response: During travel, gear shifting is inhibited. If the vehicle is at a standstill and the engine is running, ECU is not deactivated. Setting off gears can be selected (forwards and reverse). The vehicle can be driven with a starting gear selected.
If the engine is not running, the system is not available.

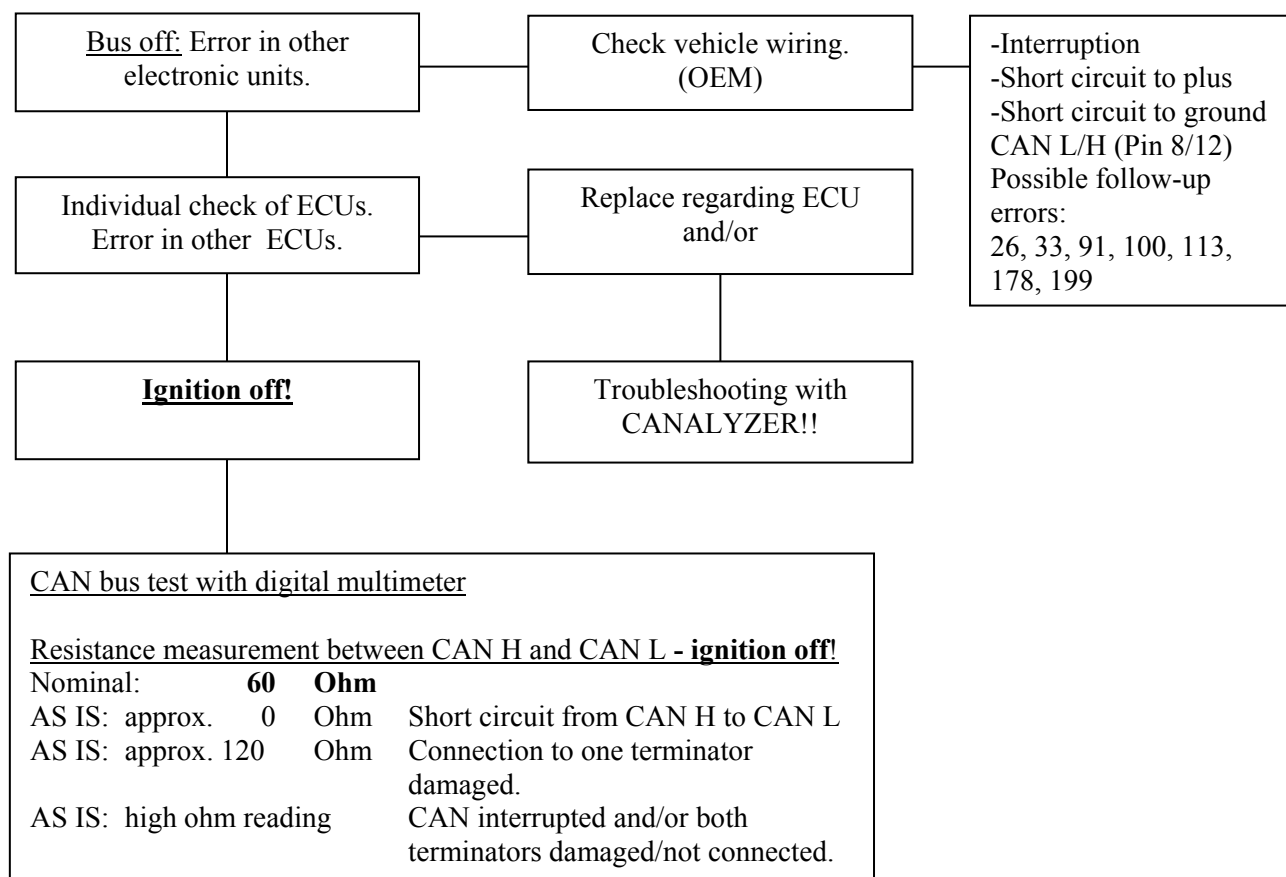
Error rectification:

Iveco error number: **B1**

Error detection: CAN system messages cannot be sent or received. Failure after timeout.

System response: During travel, gear shifts are inhibited.
Clutch opens when vehicle comes to a standstill and neutral position is automatically engaged. Other gear shifts not possible. System not available.

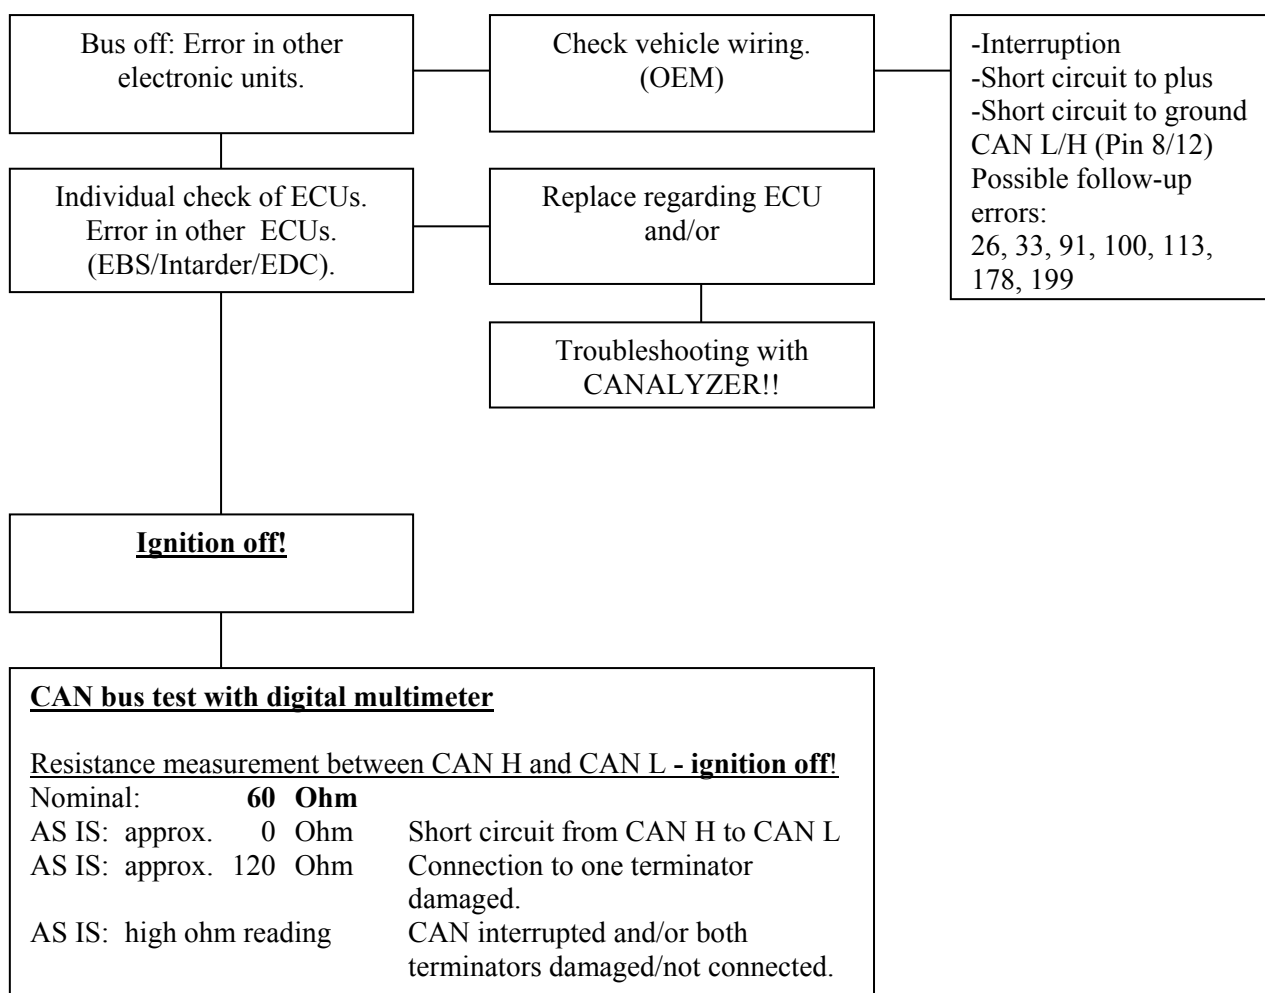
Error rectification:

Iveco error number: B2

System response: During travel, gear shifts are inhibited.
Clutch opens when vehicle comes to a standstill and neutral position is automatically engaged. Other gear shifts not possible. System not available.

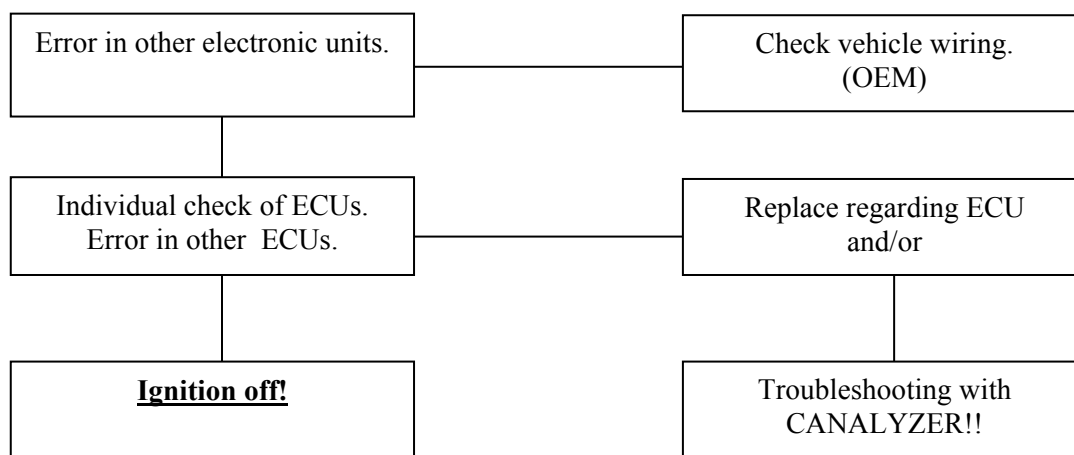
Error rectification:

Iveco error number: B3

System response: During travel, gear shifts are inhibited.
Clutch opens when vehicle comes to a standstill and neutral position is automatically engaged. Other gear shifts not possible. System not available.

CAN bus test with digital multimeter

Resistance measurement between CAN H and CAN L - ignition off!

Nominal:	60 Ohm	
AS IS: approx.	0 Ohm	Short circuit from CAN H to CAN L
AS IS: approx.	120 Ohm	Connection to one terminator damaged.
AS IS: high ohm reading		CAN interrupted and/or both terminators damaged/not connected.

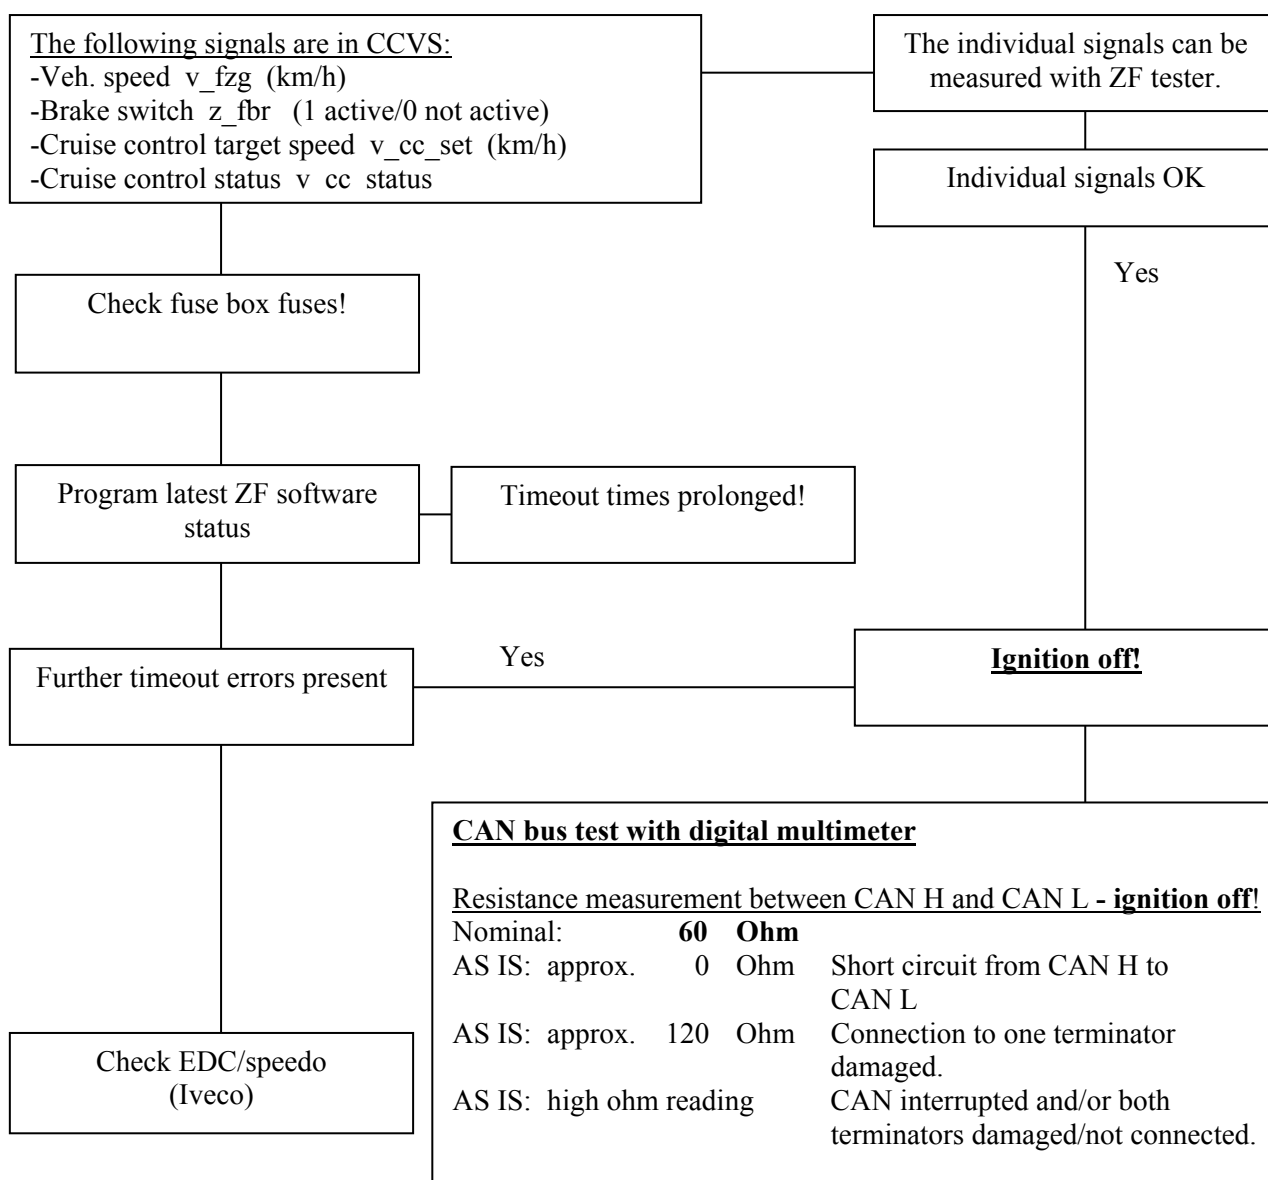
Error rectification:

Iveco error number: B6

System response: The automatic shift unit is deactivated. Wheel speed, service brake signal and cruise control status/target speed missing. In coasting mode, it is assumed that the service brake signal is active. The clutch opens a little earlier.

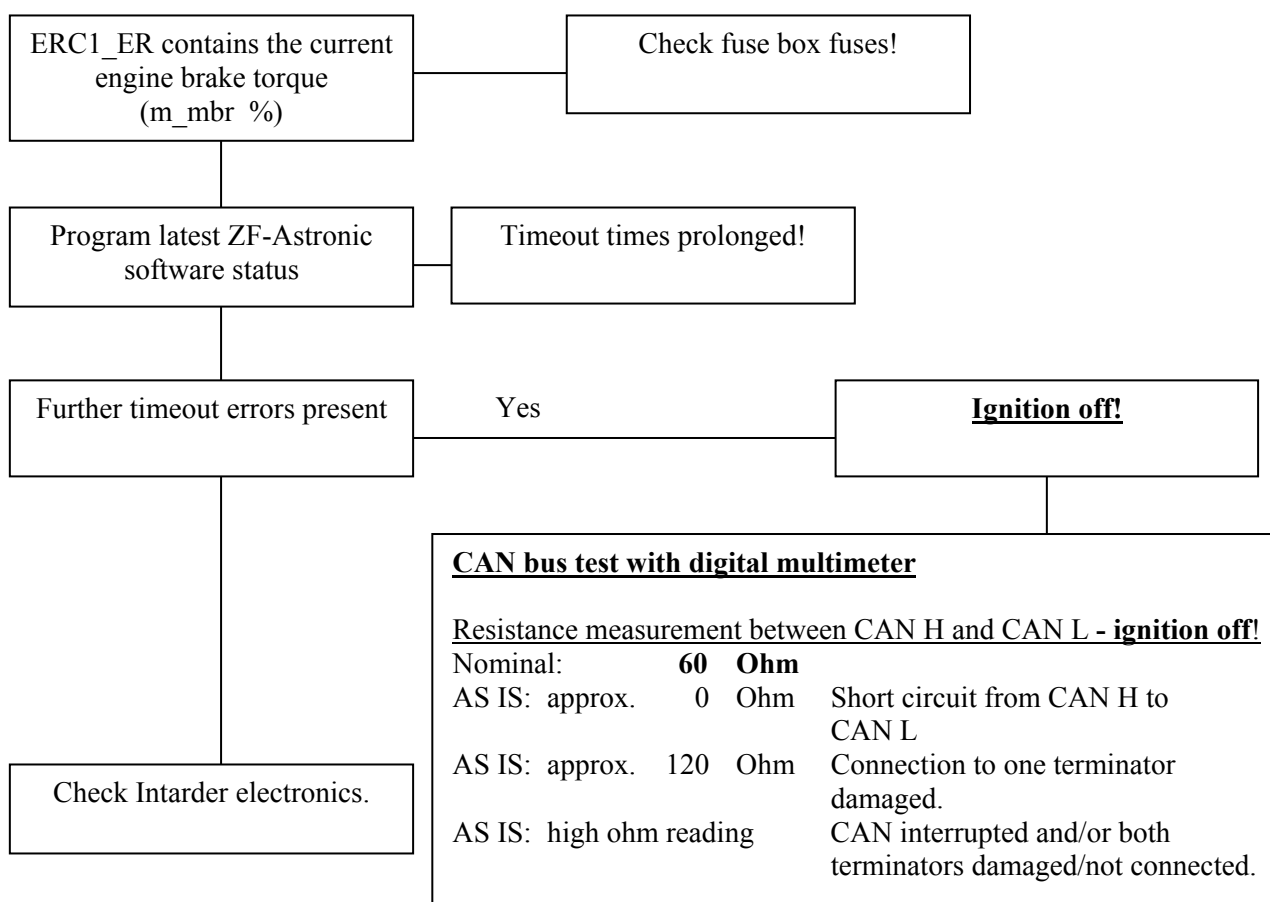
Error rectification:

Iveco error number: B7

System response: The automatic shift unit is deactivated. No information about the engine braking torque. If the engine brake is active, the shift quality may be reduced.
It is assumed that the engine brake is not active. No other functional restrictions.

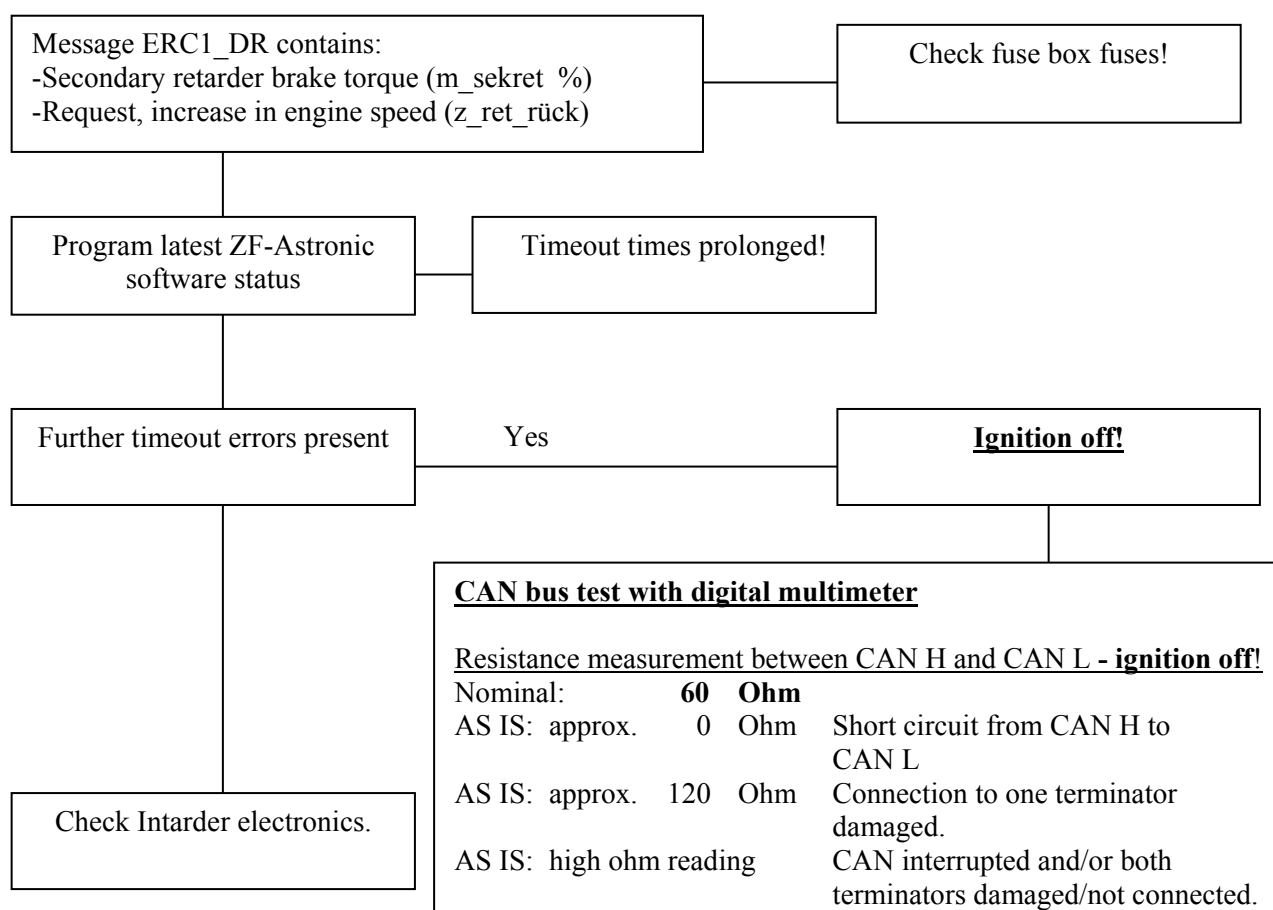
Error rectification:

Iveco error number: B8

System response: The automatic shift unit is deactivated. Manual shifting possible.
If the vehicle comes to standstill, the mid-starting gear is selected.
No other functional restrictions.

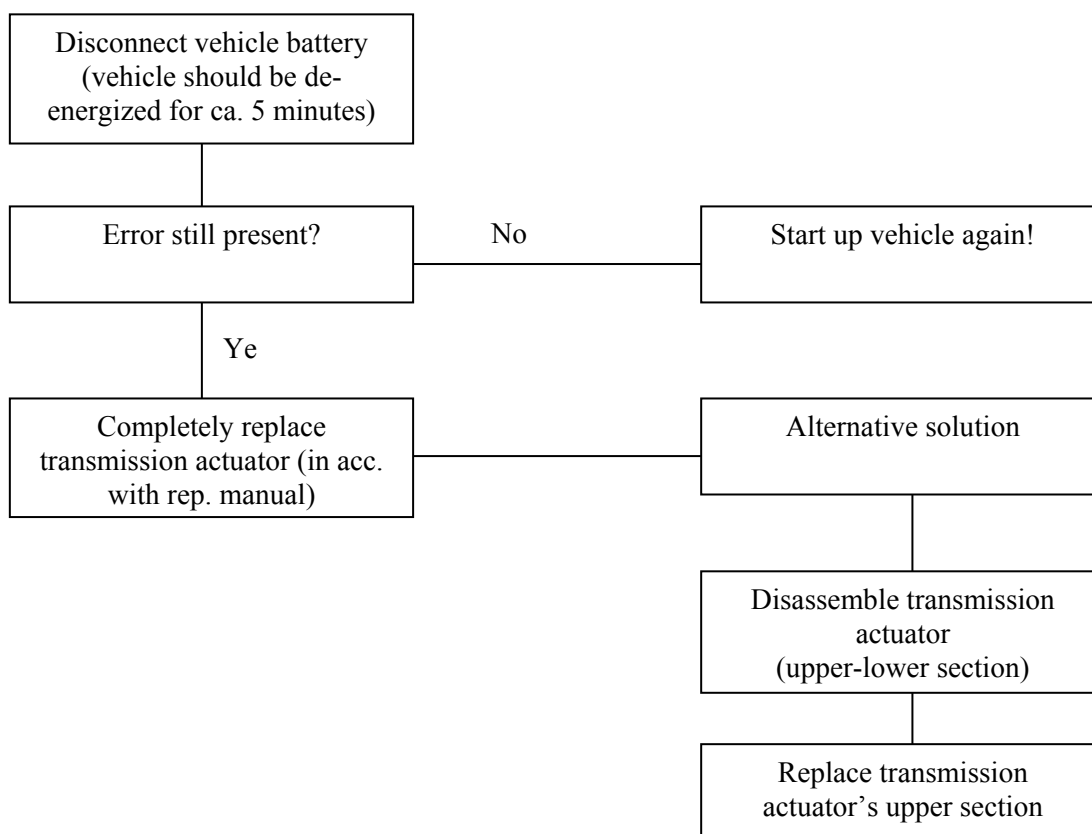
Error rectification:

Iveco error number: BC

System response: During travel, gear shifts are inhibited. The clutch opens as soon as the vehicle comes to a standstill. When the vehicle stops Neutral position is automatically engaged. Other gear shifts not possible. System not available.

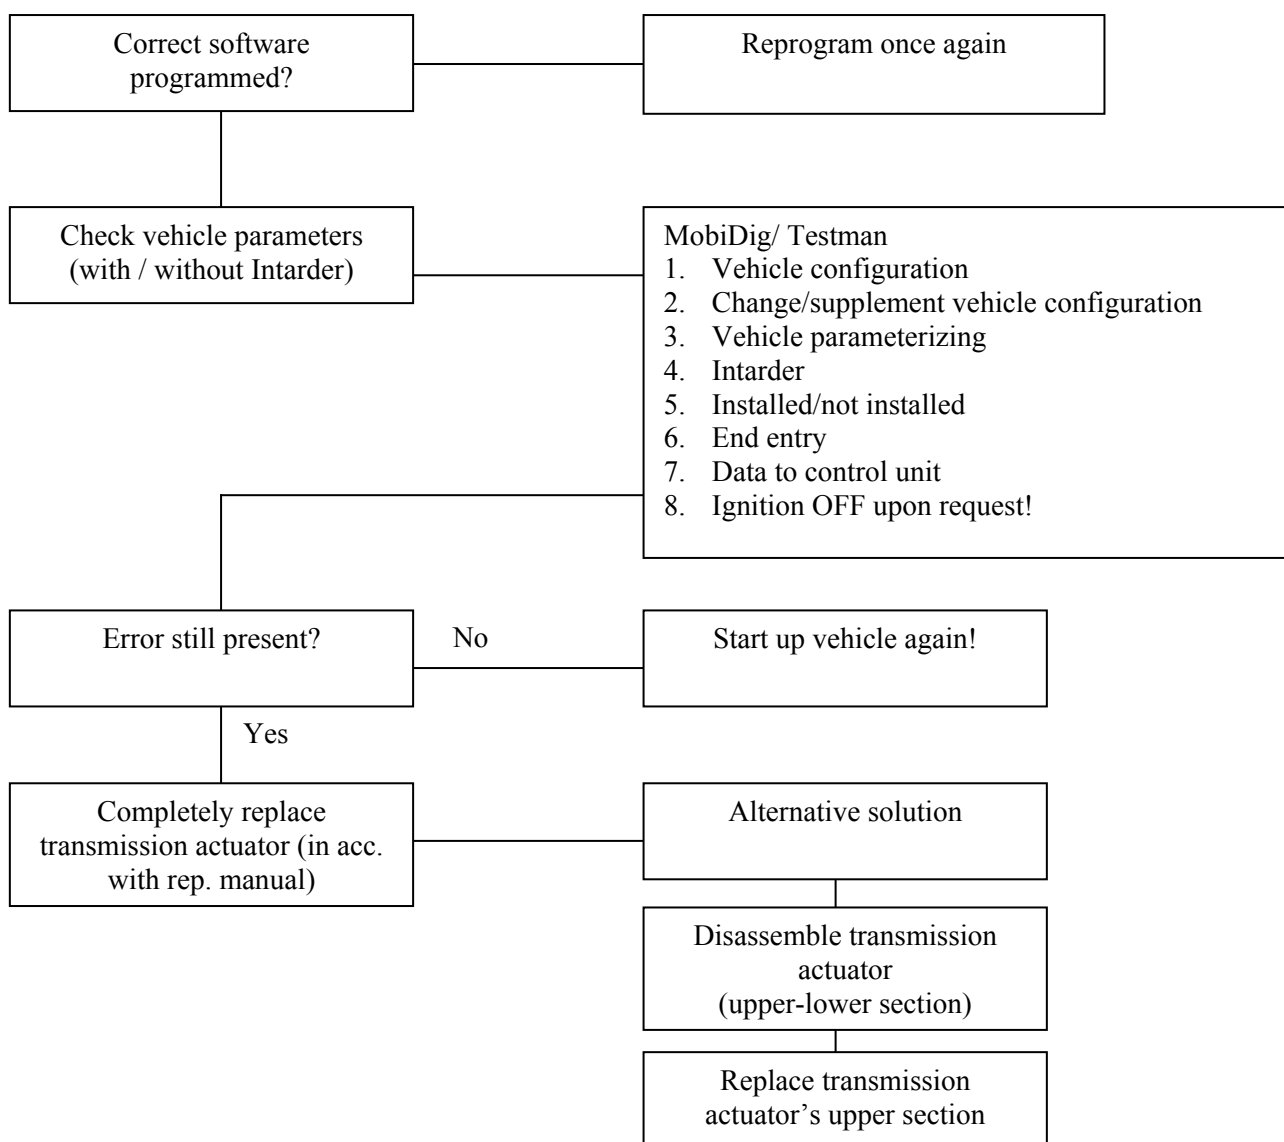
Error rectification:

Iveco error number: BF

System response: Gear shifts are blocked. The clutch opens as soon as the vehicle comes to a standstill. When vehicle stops, neutral position is automatically engaged. Other gear shifts not possible. System not available.
