Failure tree

IVECO

Edition: 2004-02
SW31_13e

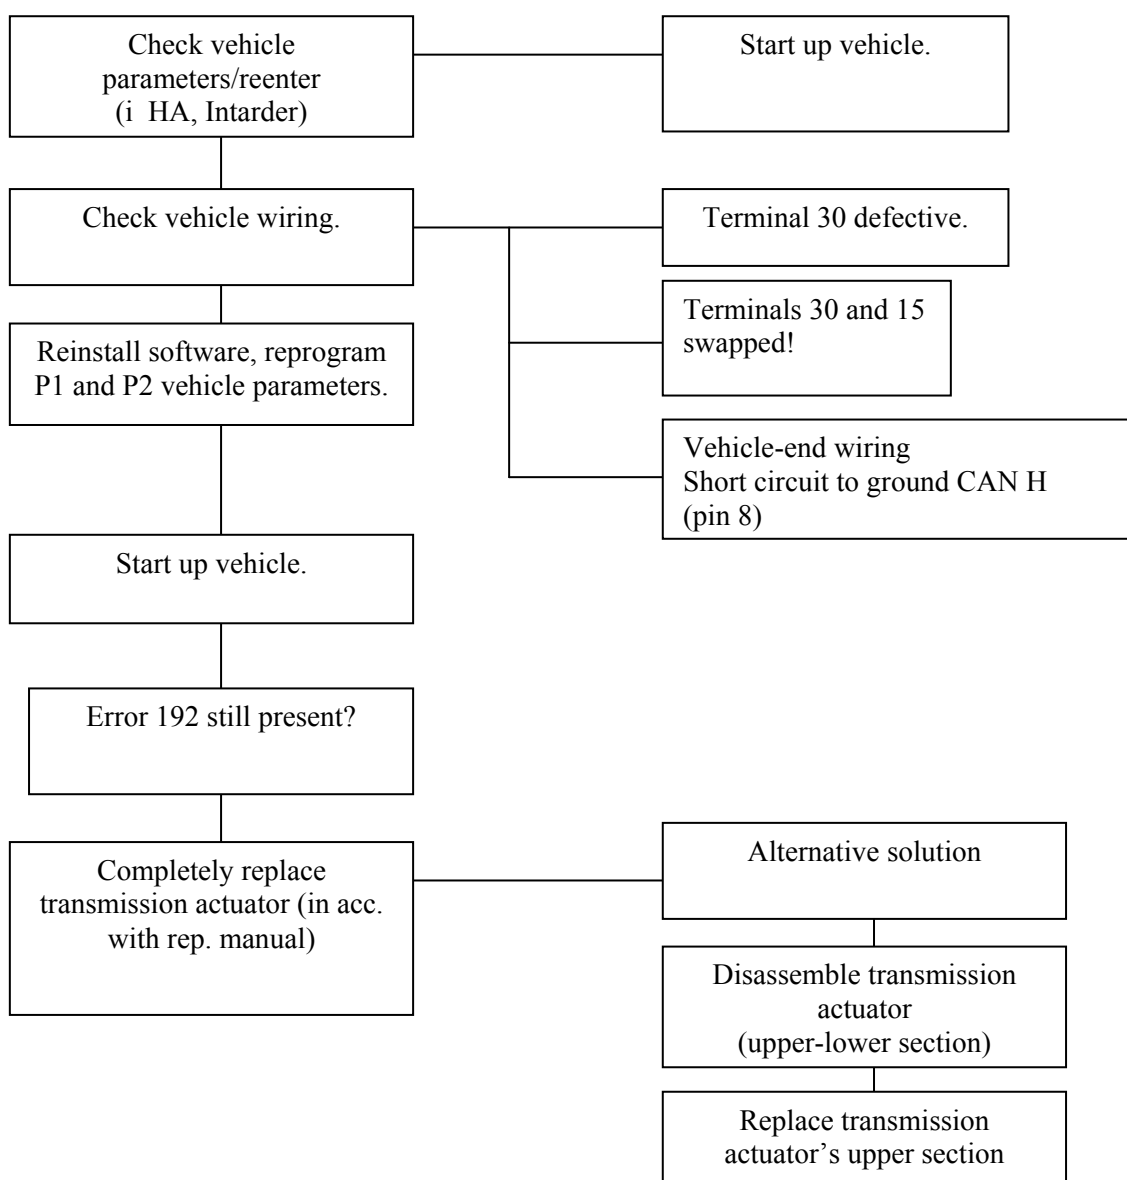
Error rectification:

Iveco error number: C0

System response: Gear shifts are blocked. The clutch opens as soon as the vehicle comes to a standstill. When vehicle stops, neutral position is automatically engaged. Other gear shifts not possible. System not available.

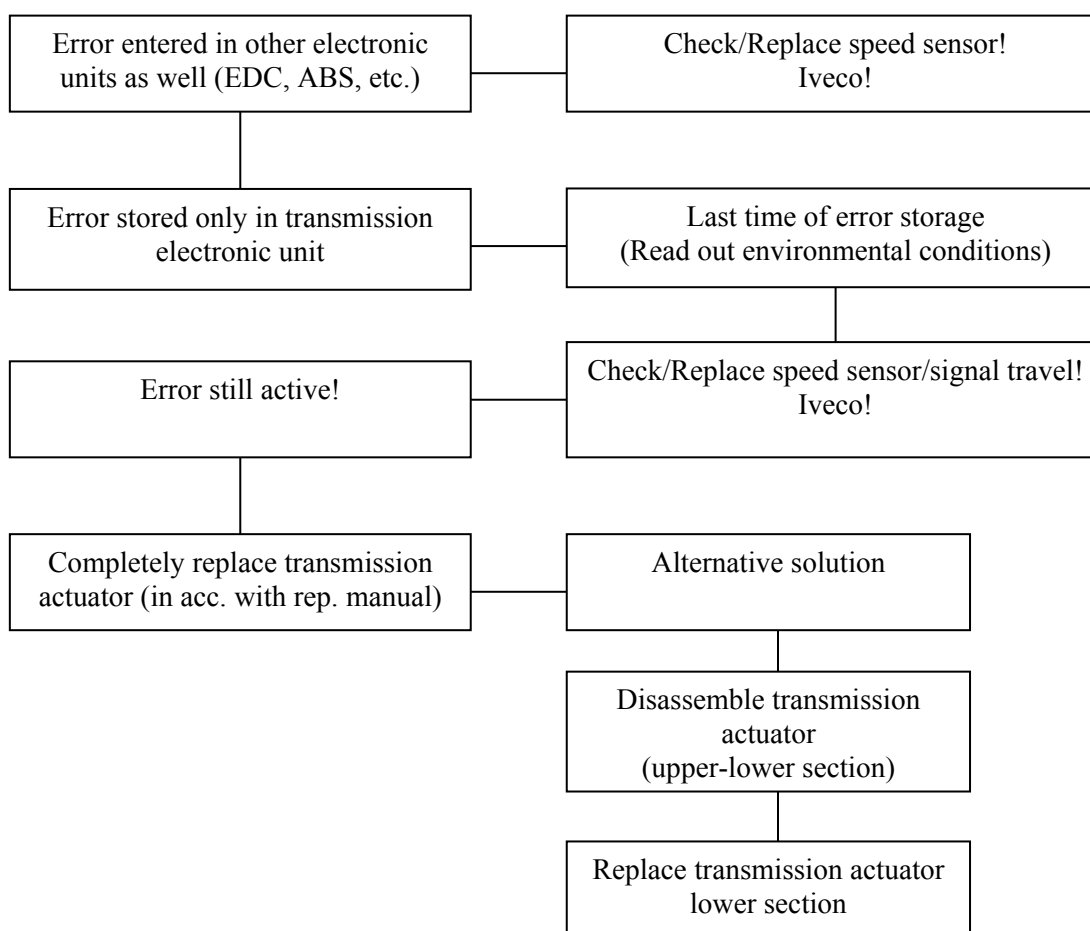
Error rectification:

Iveco error number: C2

Error description: Failure of both signal sources for the front axle speed.

System response: The automatic shift unit is deactivated. No further system restrictions.

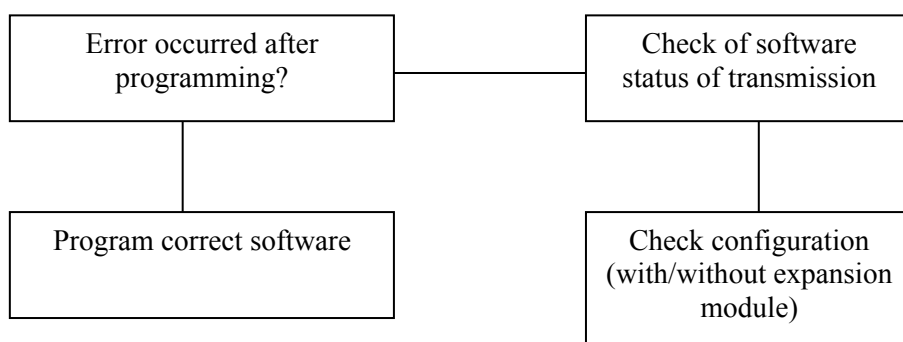
Error rectification:

Iveco error number: E3

System response: Gearshifts locked. When vehicle stops, Neutral position is automatically engaged. System not available.
