# Fuller Transmissions

## TRTS0070

October 2007

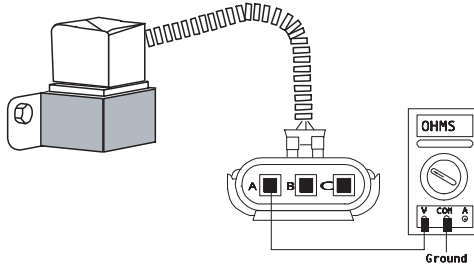
Step B	Procedure	Condition	Action
	1. Measure resistance between Top 2 valve connector pin A (red wire) and ground.	<p>If resistance is more than 10K ohms or infinite →</p> <p>If resistance is less than 10K ohms →</p>	<p>Go to <b>Step C</b>.</p> <p><b>Replace Top 2 valve. Go to Step V.</b></p>

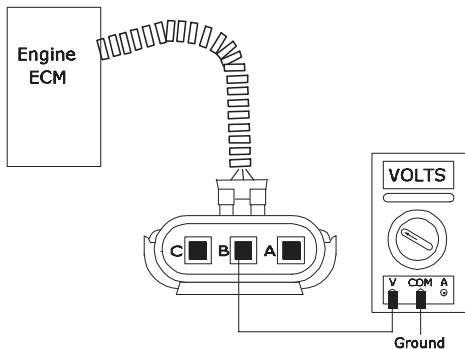
Step C	Procedure	Condition	Action
	<p>1. Key off.</p> <p>2. Disconnect battery positive (+) cable.</p> <p>3. Measure resistance between vehicle interface harness connector pin B and ground.</p>	<p>If resistance is 0 to .3 ohms →</p> <p>If voltage is outside of range →</p>	<p>Top 2 valve is functioning properly, the problem exists in engine ECM or vehicle harness. Repair according to vehicle OEM recommendations. Go to <b>Step V</b>.</p> <p>Faulty ground. Repair / replace vehicle interface harness.</p>

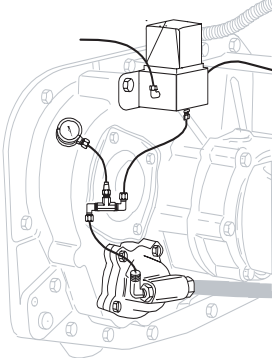
Step B	Procedure	Condition	Action
	<ol style="list-style-type: none"> <li>1. Remove gauge from Top 2 valve signal line.</li> <li>2. Locate the signal line from the Roadranger valve to the Top 2 valve P1 port. Tee the pressure gauge into the signal line at the Top 2 valve.</li> </ol>		
	<ol style="list-style-type: none"> <li>3. Move the splitter button forward and back. Observe the pressure gauge.</li> </ol>	<p>→ If the pressures rapidly rises to regulated pressure when the button is forward <b>and</b></p> <p>Pressure rapidly decreases when the button is back →</p> <p>If the pressure does not reach regulated pressure or pressure does not change rapidly →</p>	<p>Go to <b>Step C.</b></p> <p>Go to <b>Step D.</b></p>

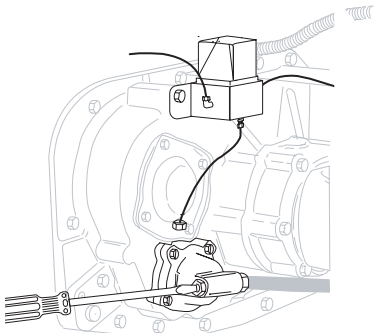
<p>10 Speed Only</p>		
	<p><b>Note:</b> Blow shop air into signal line opening with a rubber tip air gun.</p>	<p>If air briefly exhausts when shop air is applied →</p>	<p>Go to <b>Step I.</b></p>
		<p>Air does not exhaust when shop air is applied →</p>	<p>Go to <b>Step H.</b></p>

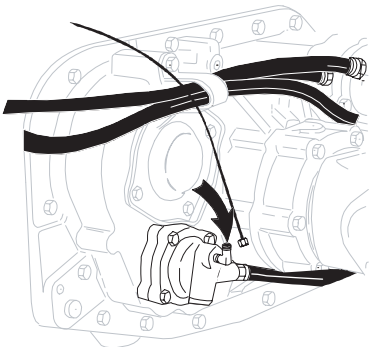
<p>13 and 18 Speed Only</p>		
	<p><b>Note:</b> Spool Valve Cylinder Only: Through the signal line opening use a small screwdriver to push in the spool valve. Valve travels approximately 1/4 inch.</p>	<p>If splitter shifts →</p>	<p><b>Replace spool valve.</b> Go to <b>Step V.</b></p>
